# Underlying Causes of Flooding in *Haor* Region and Waterlogging in Sylhet City

**Md. Khalequzzaman, Ph.D.**

Professor of Geology

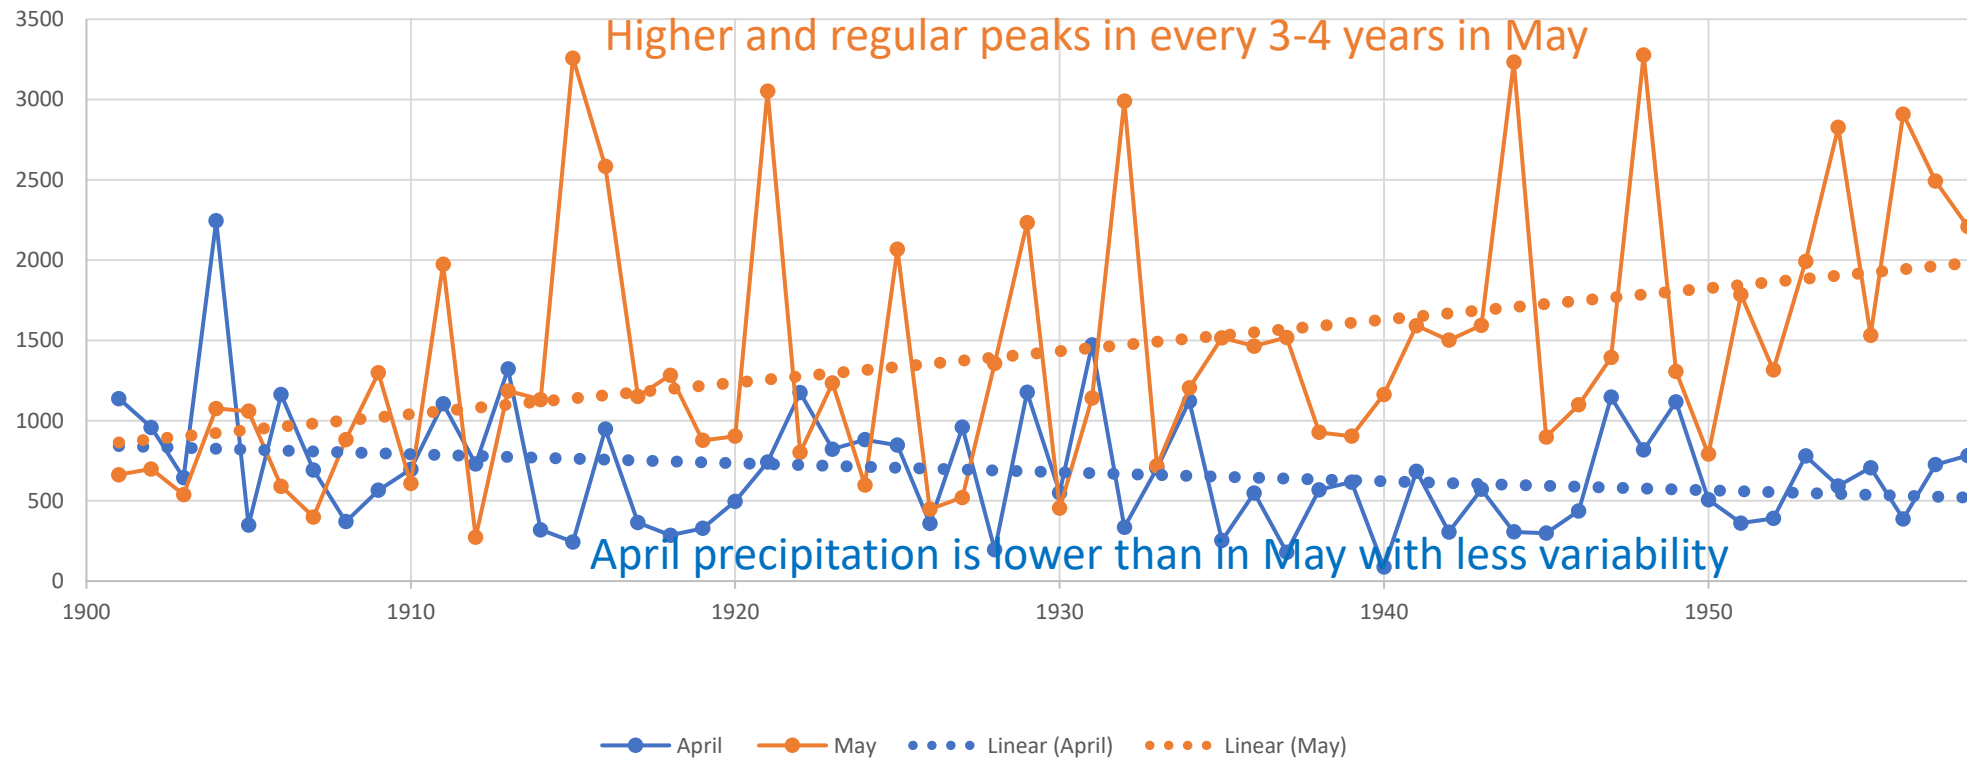
# Trend in April-May Precipitation Patterns at Cherapunji, Meghalaya during 1901-1958

Cherapunji April-May Precipitation (mm): 1901-1958

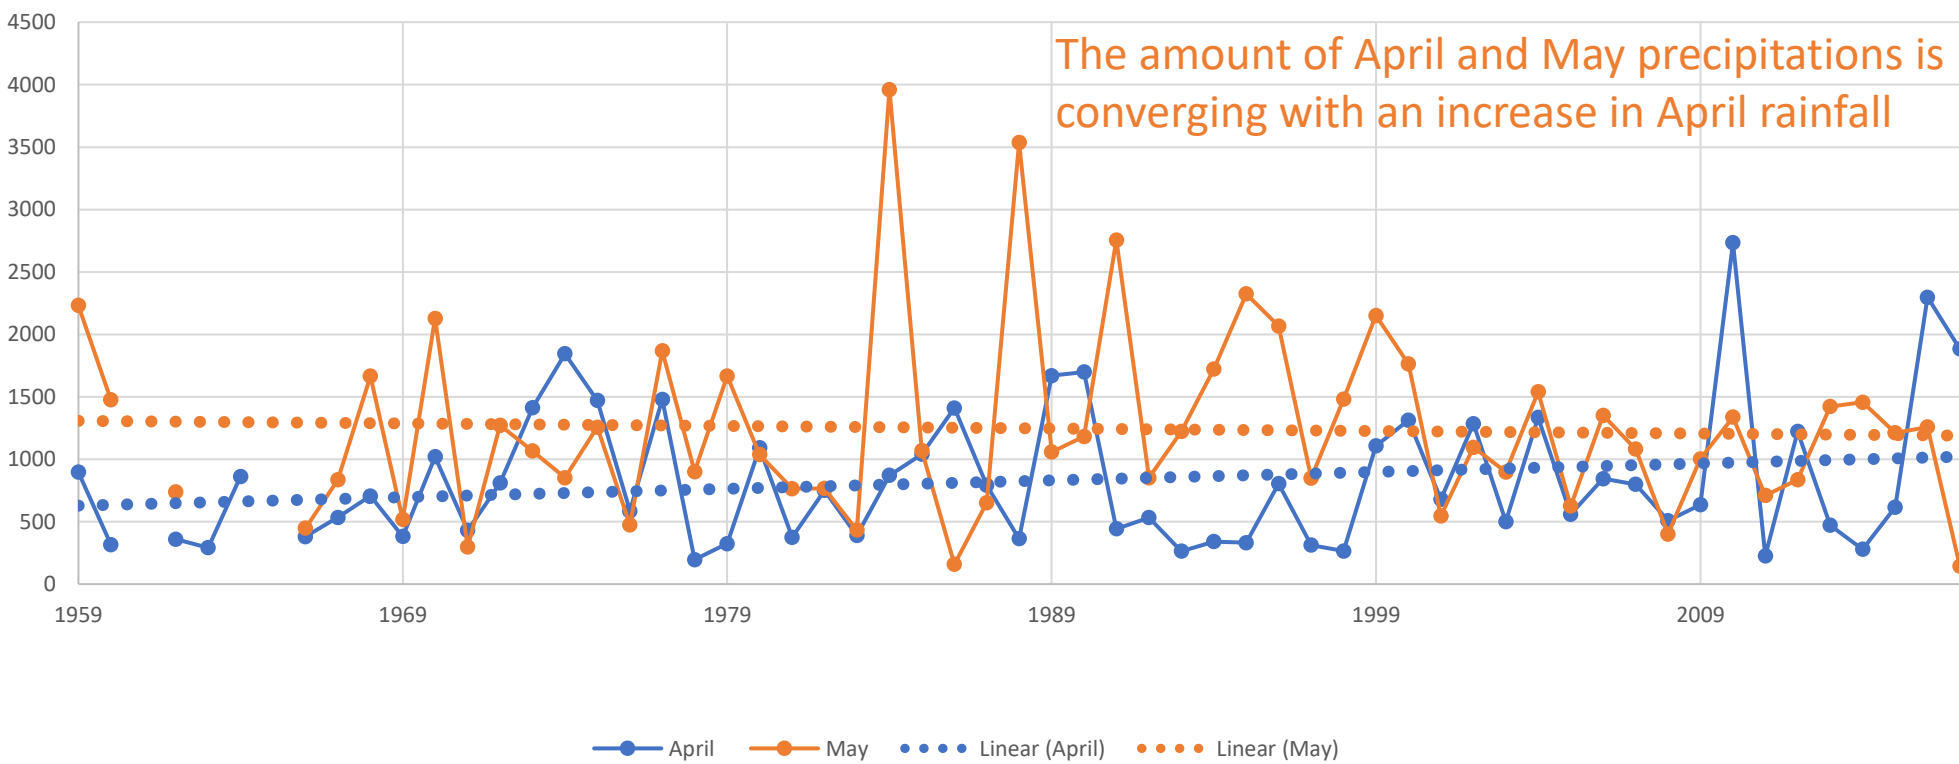
# Trend in April-May Precipitation Patterns at Cherapunji, Meghalaya during 1959-2017

Cherapunji April-May Precipitation (mm): 1959-2017

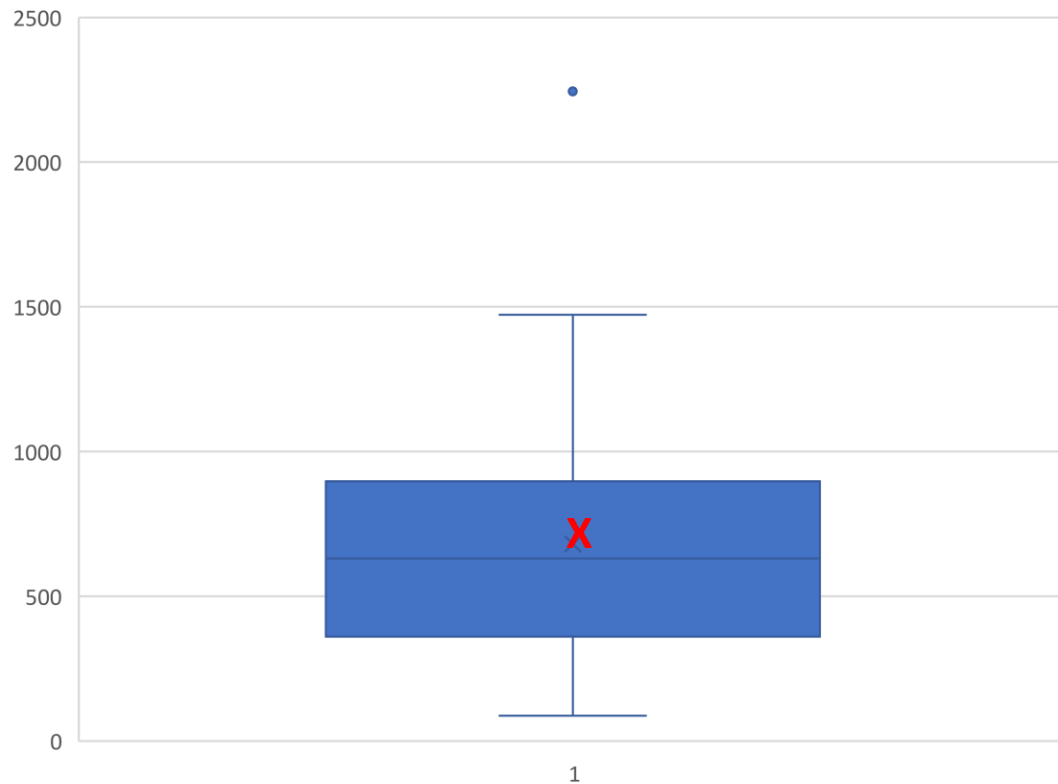
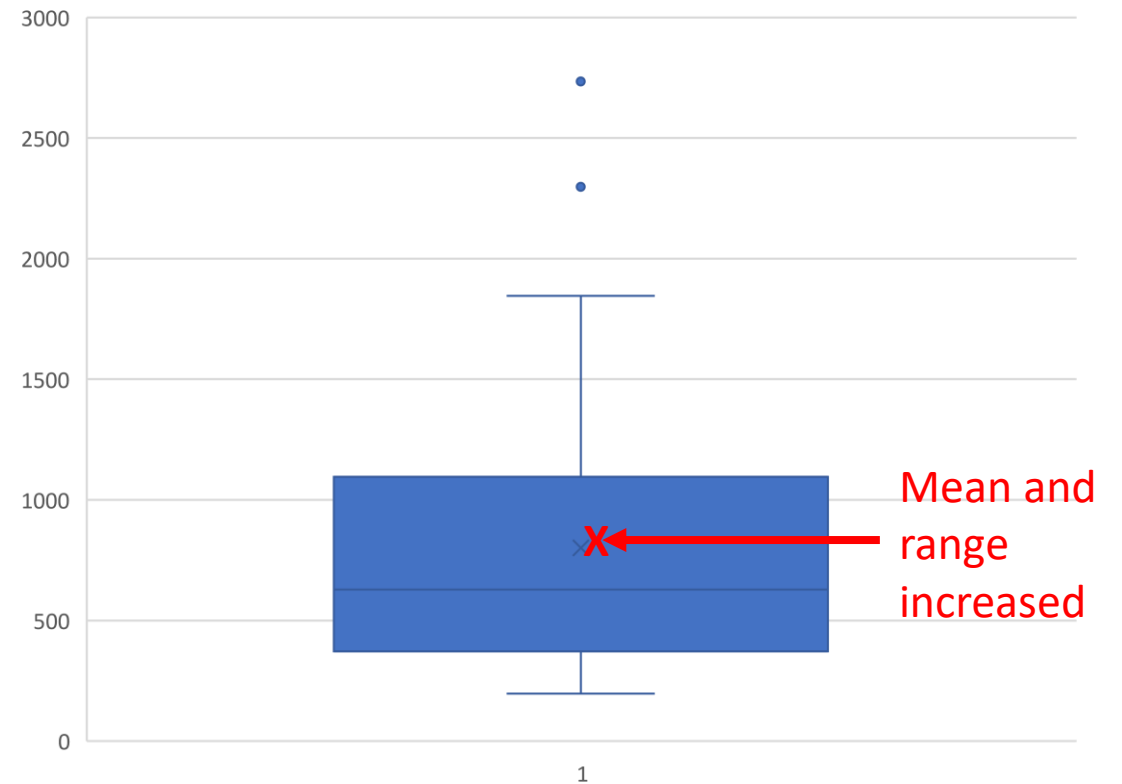
# Changing total Precipitation Patterns in Cherapunji during 1901-1958 and 1959-2017

Annual Precipitation: 1901-58

Annual Precipitation: 1959-2016

Anova F(1, 113) 1.86;  $p < 0.05 \Rightarrow$  Null hypothesis is not rejected ( $F > 3.96$  is needed to reject the null hypothesis)

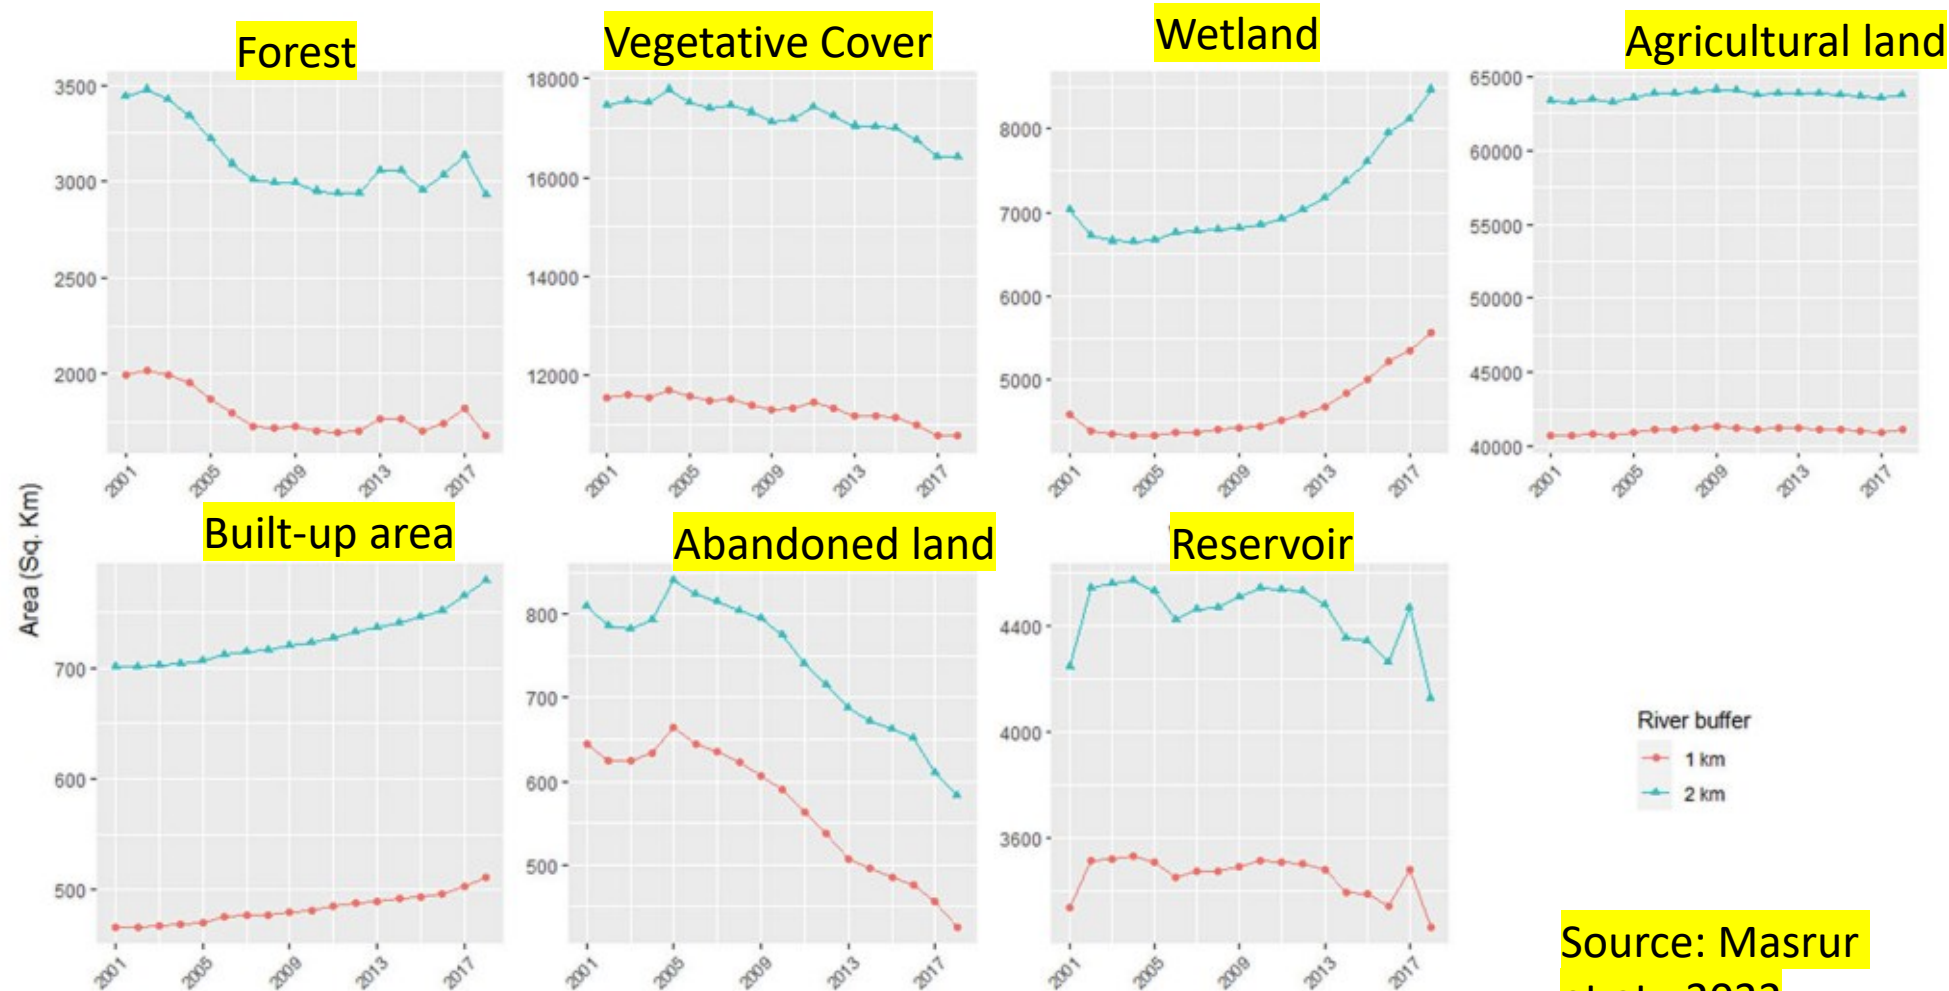
# Landuse changes in floodplains during 2000-2018

**Figure 9.** Annual pattern of major LULC areas (km<sup>2</sup>) within 1- and 2-km of river buffers.

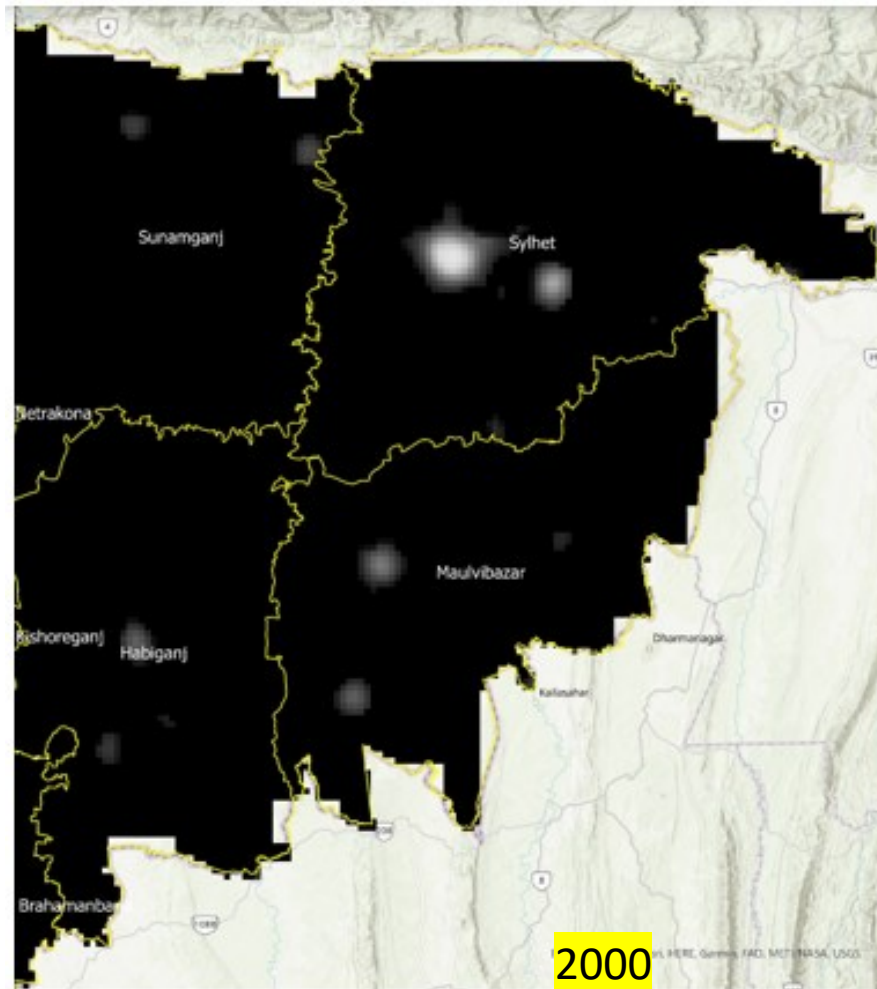
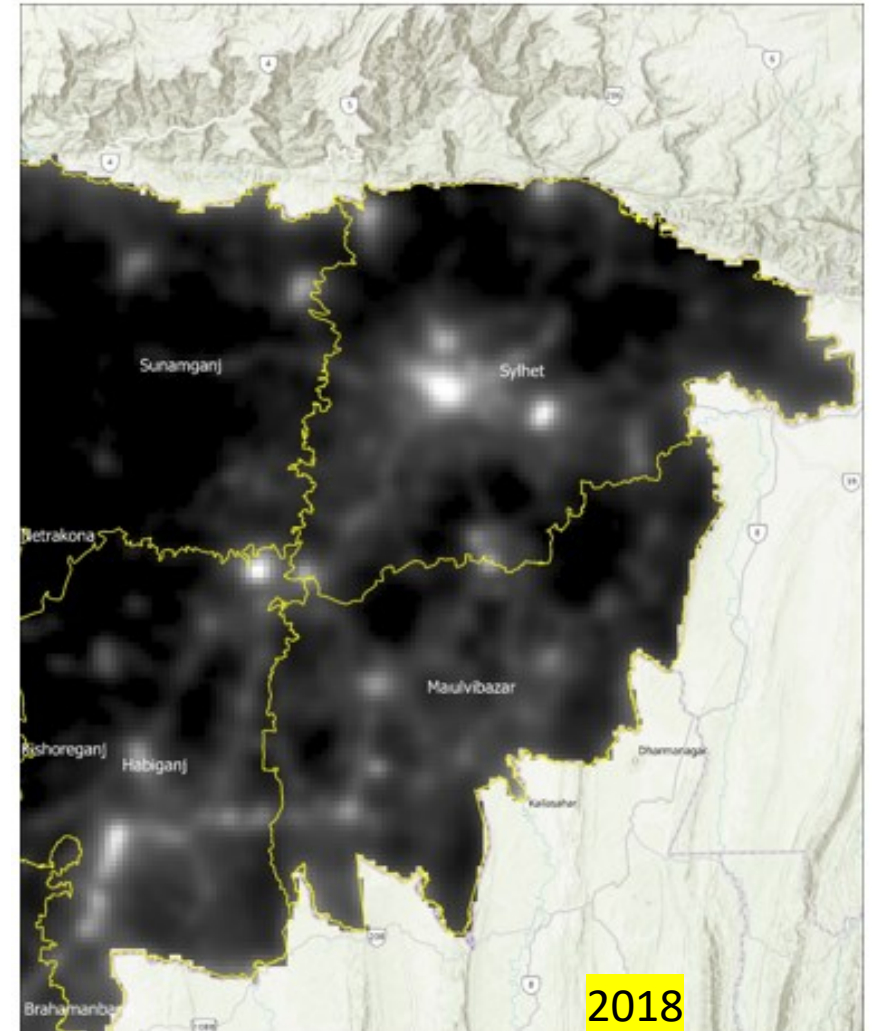
# Change in Night Tile Light in Greater Sylhet Area: 2000-2018

NTL luminosity data in 2000. Bright areas indicate night lights.

Urbanization  
has increased  
in floodplain=>  
adverse impact  
on flooding

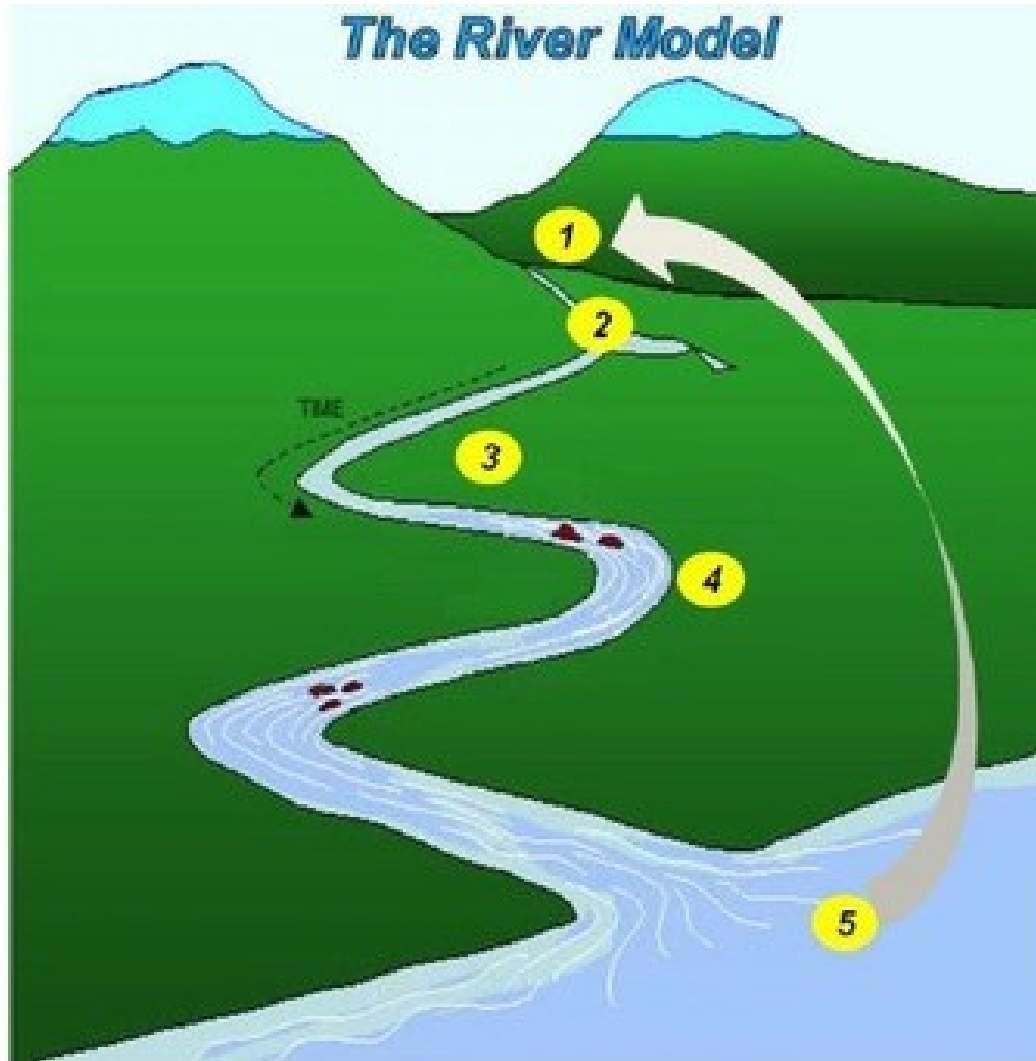
# Morphological Changes in a River Flowing Downstream

- Rivers become wider, deeper, and faster as they flow downstream to accommodate additional baseflow and flow from tributaries
- Cross-sectional area of rivers increases either by widening or deepening or both as they flow downstream
- Let's examine the morphology of the river system as they flow downstream (**next few slides**)

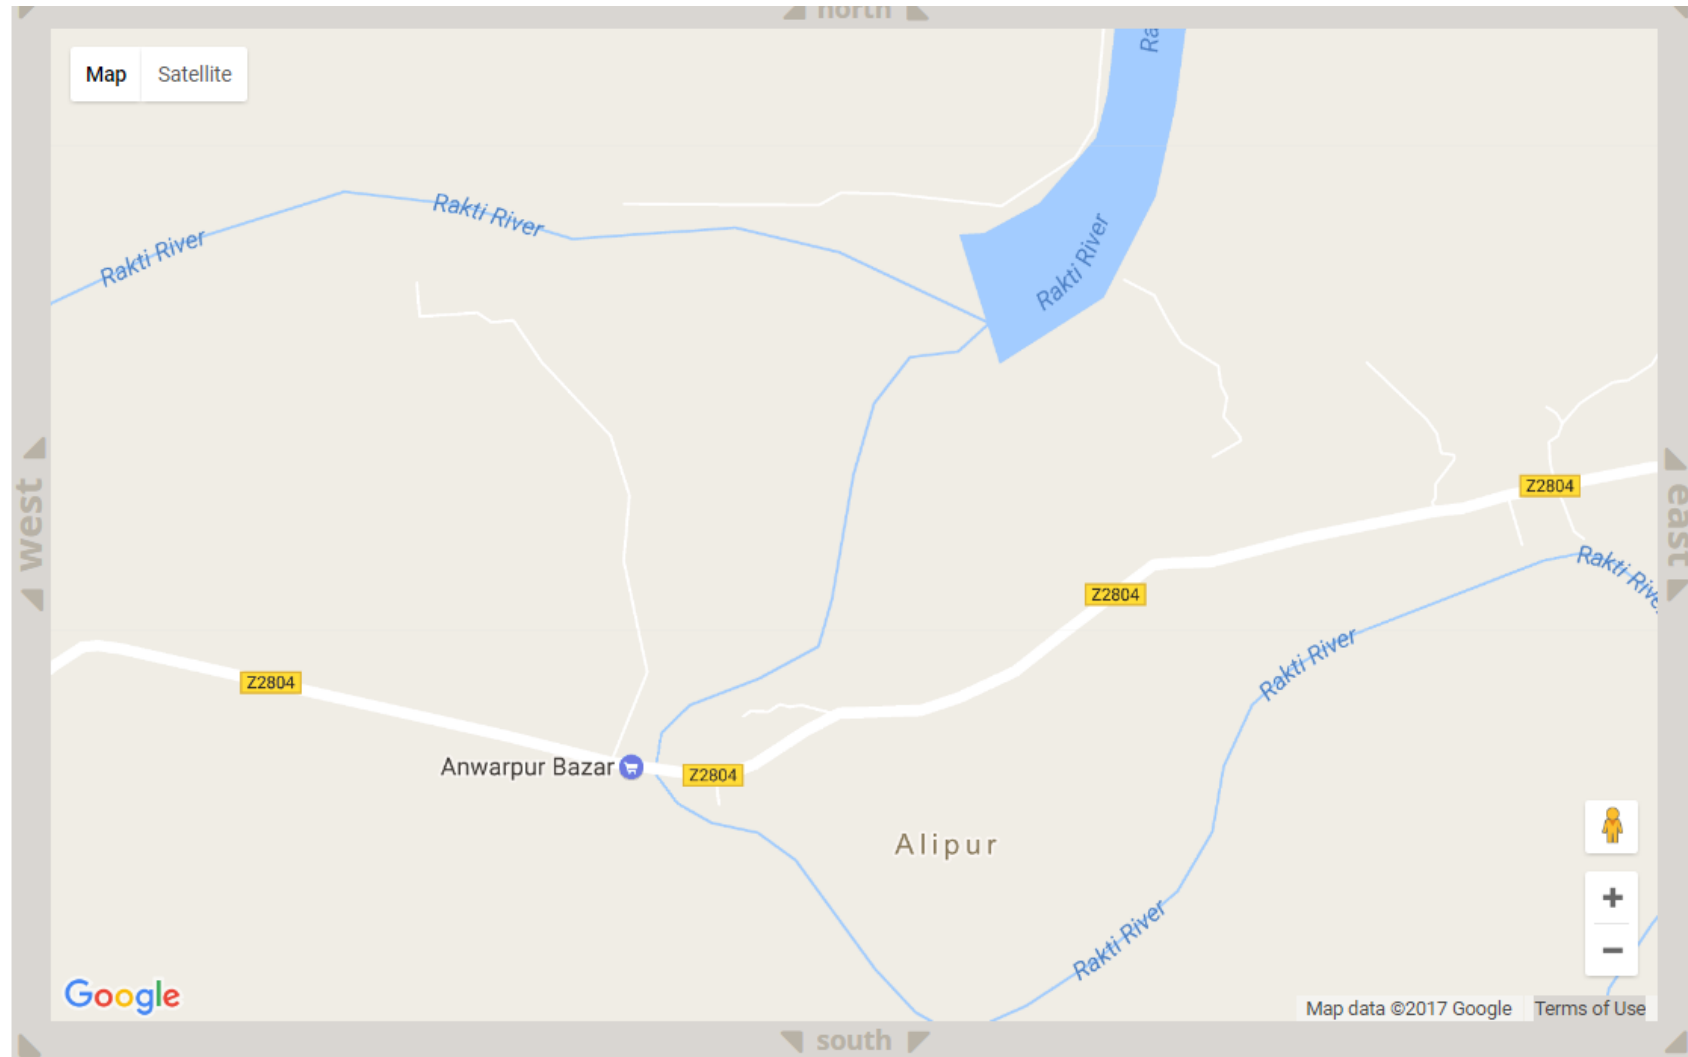
# Rakti River

- The river narrows downstream, causing water to overflow the banks during rainy season

Most rivers in the haor region have smaller cross-sectional area in downstream locations, resulting in overflow of banks

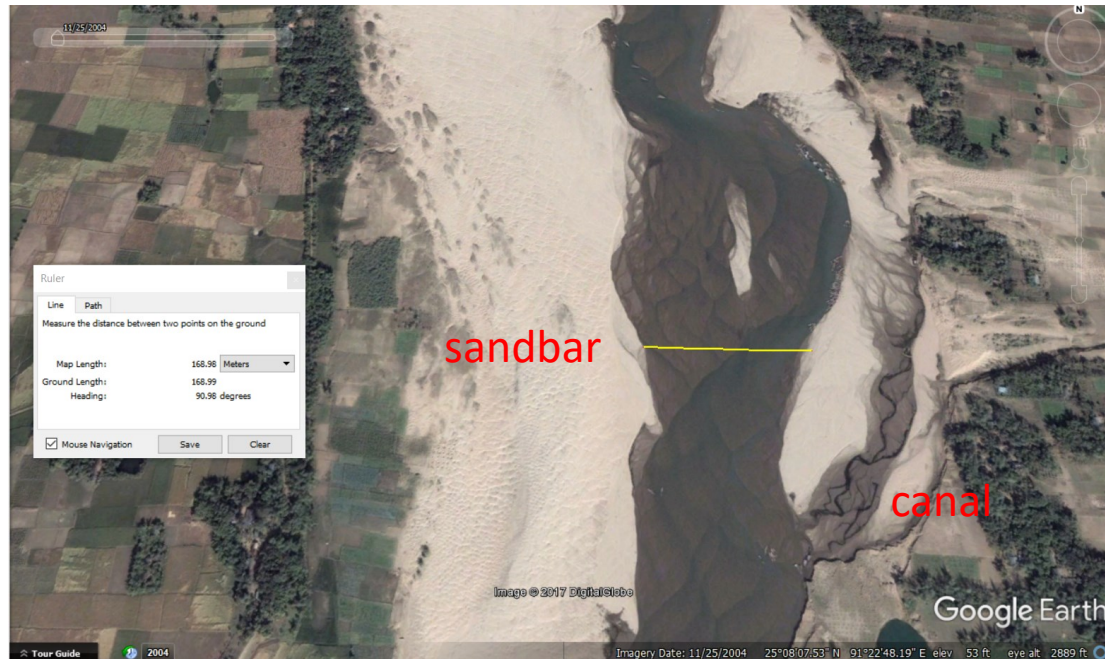
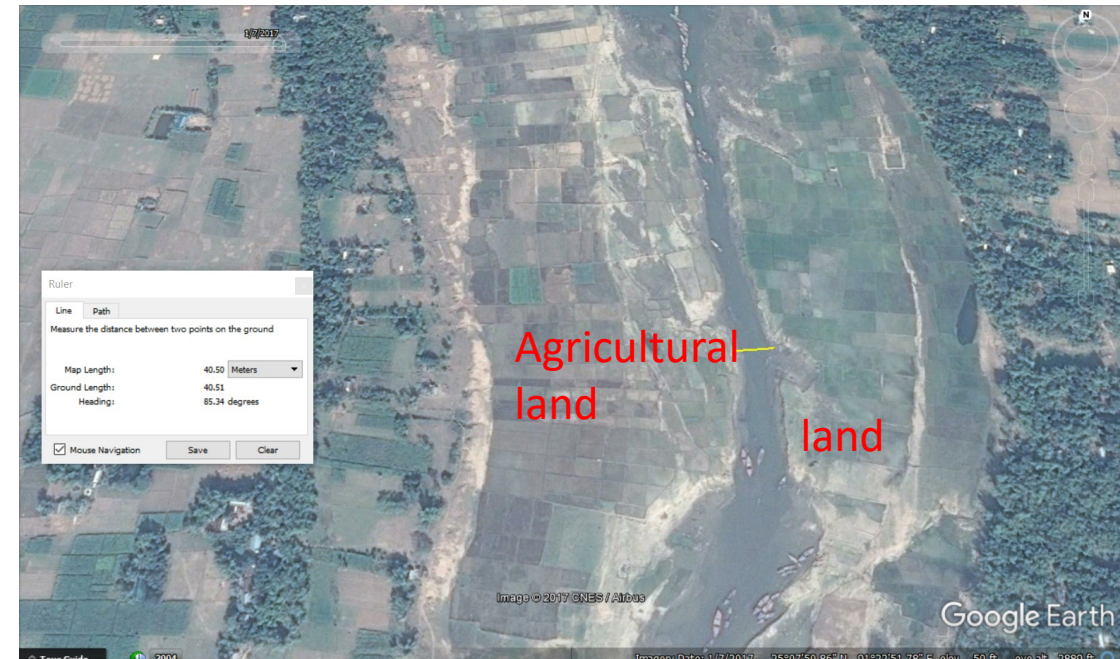
# Jadukata River: Reduction of the width from 168 m to 40 m during 2004-2017

**23% of the original river width left in 13 years**

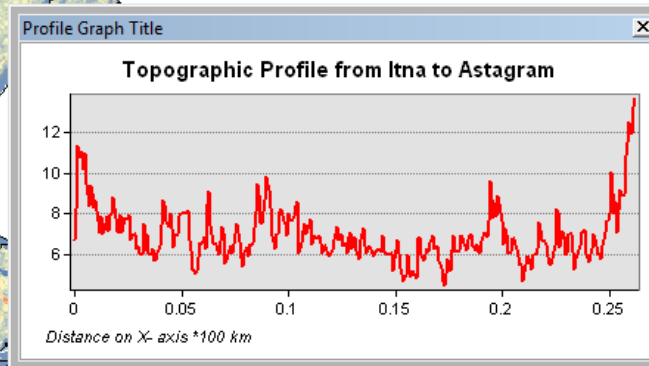
Elevation changes along the Itna-  
Mithamoin-Austagram highway

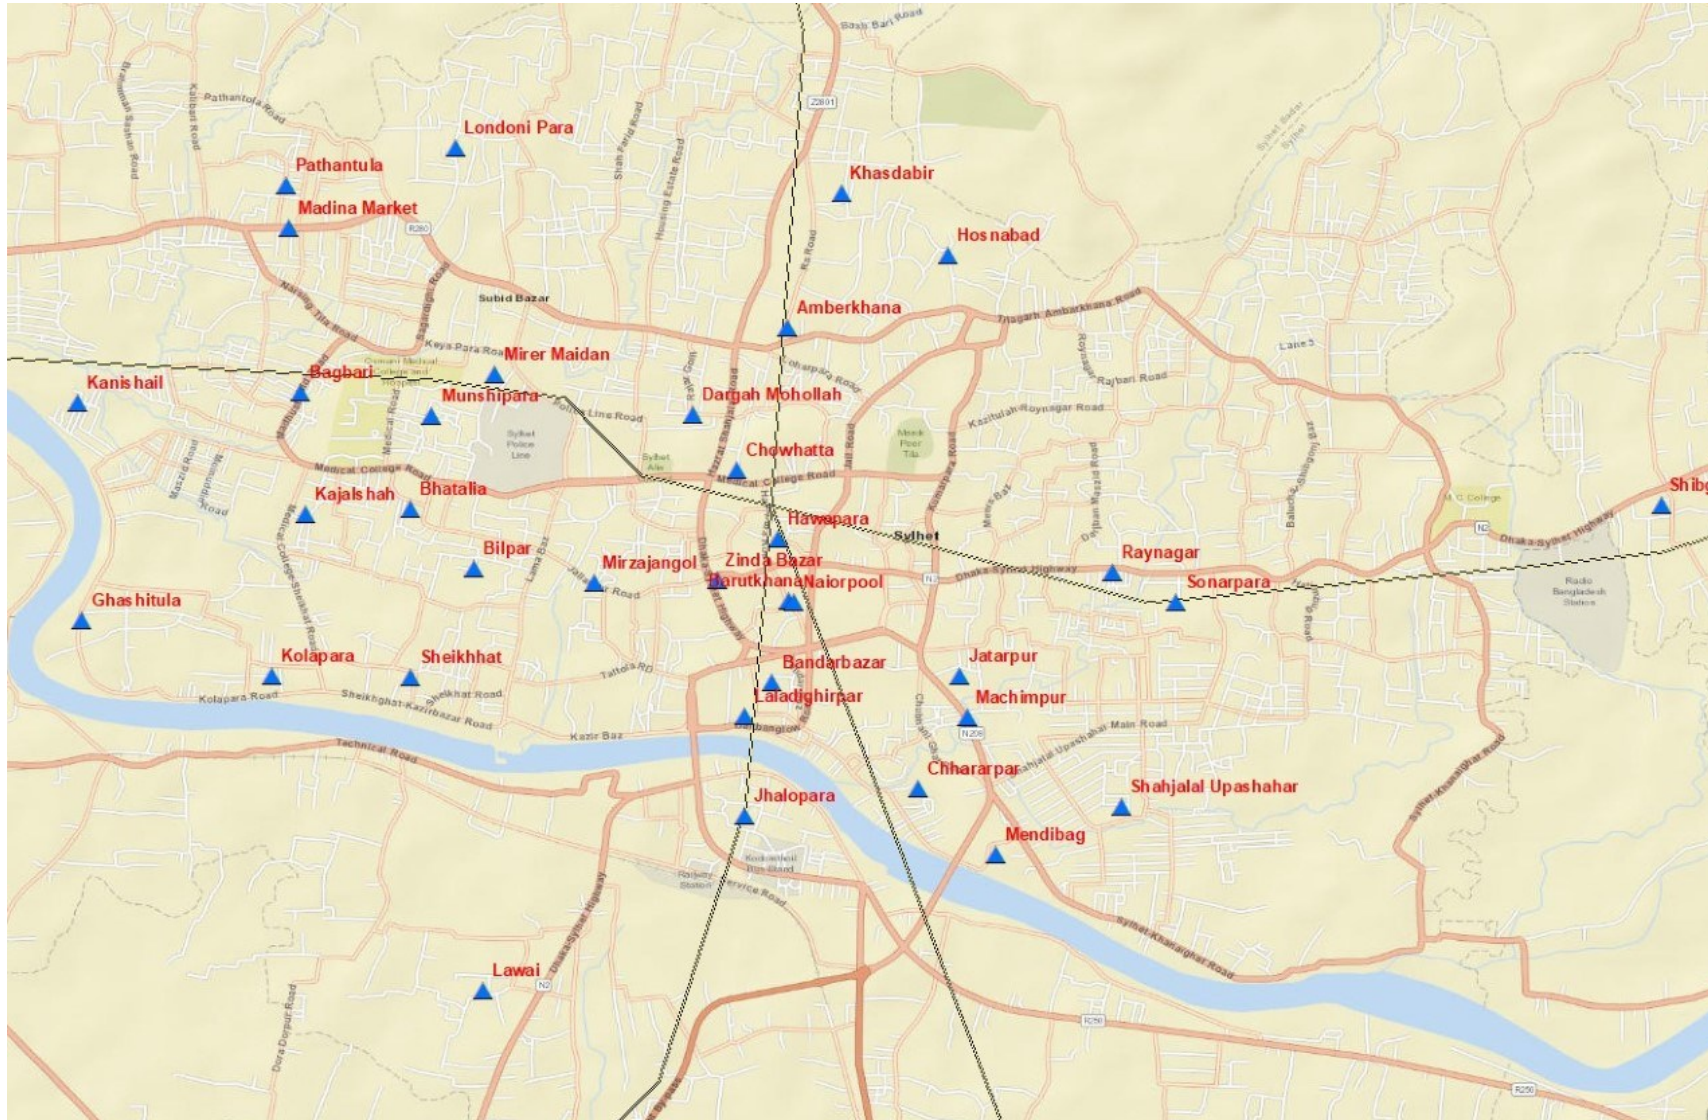
# Locations of waterlogging in Sylhet City

Waterlogging is not confined an geographic area not it is connected to any particular river or stream.

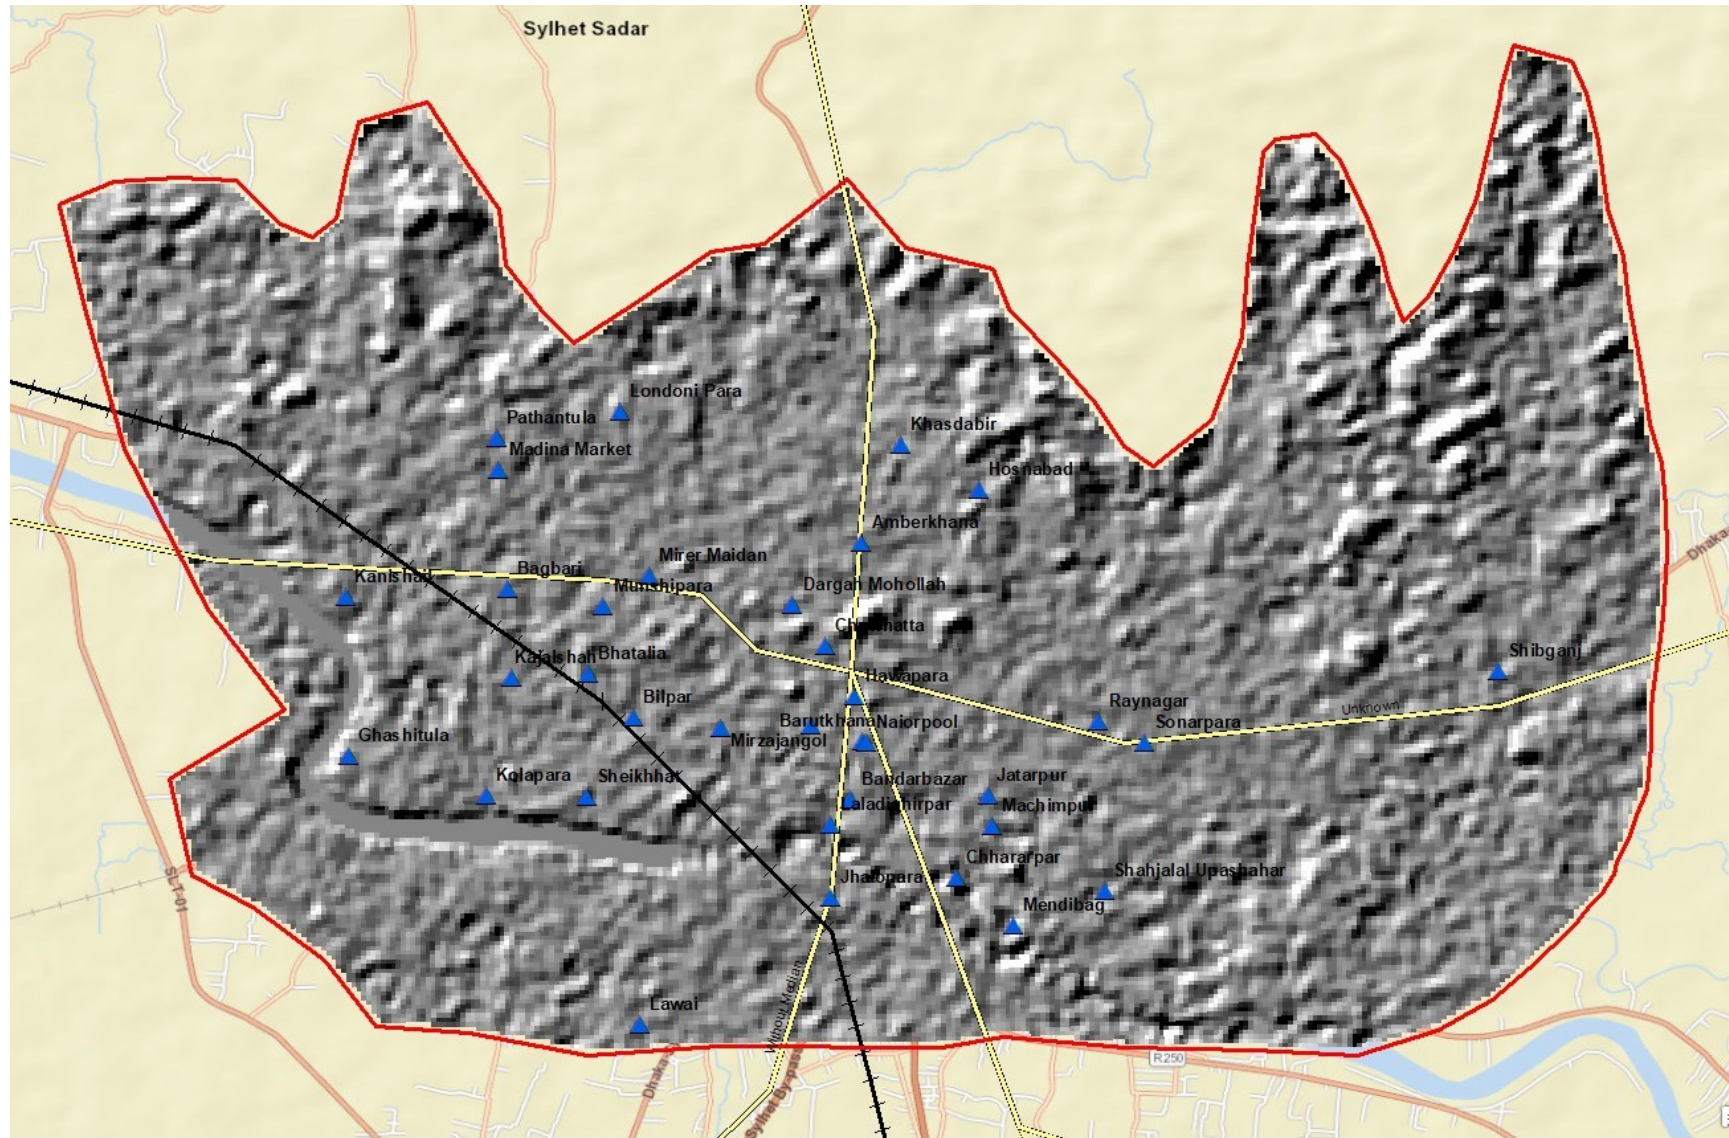
# DEM of Sylhet City

**Abundance of hills in the NE part**

**Inadequate natural drainage**

**Eastern segment of the Surma River appears to be non-functional**

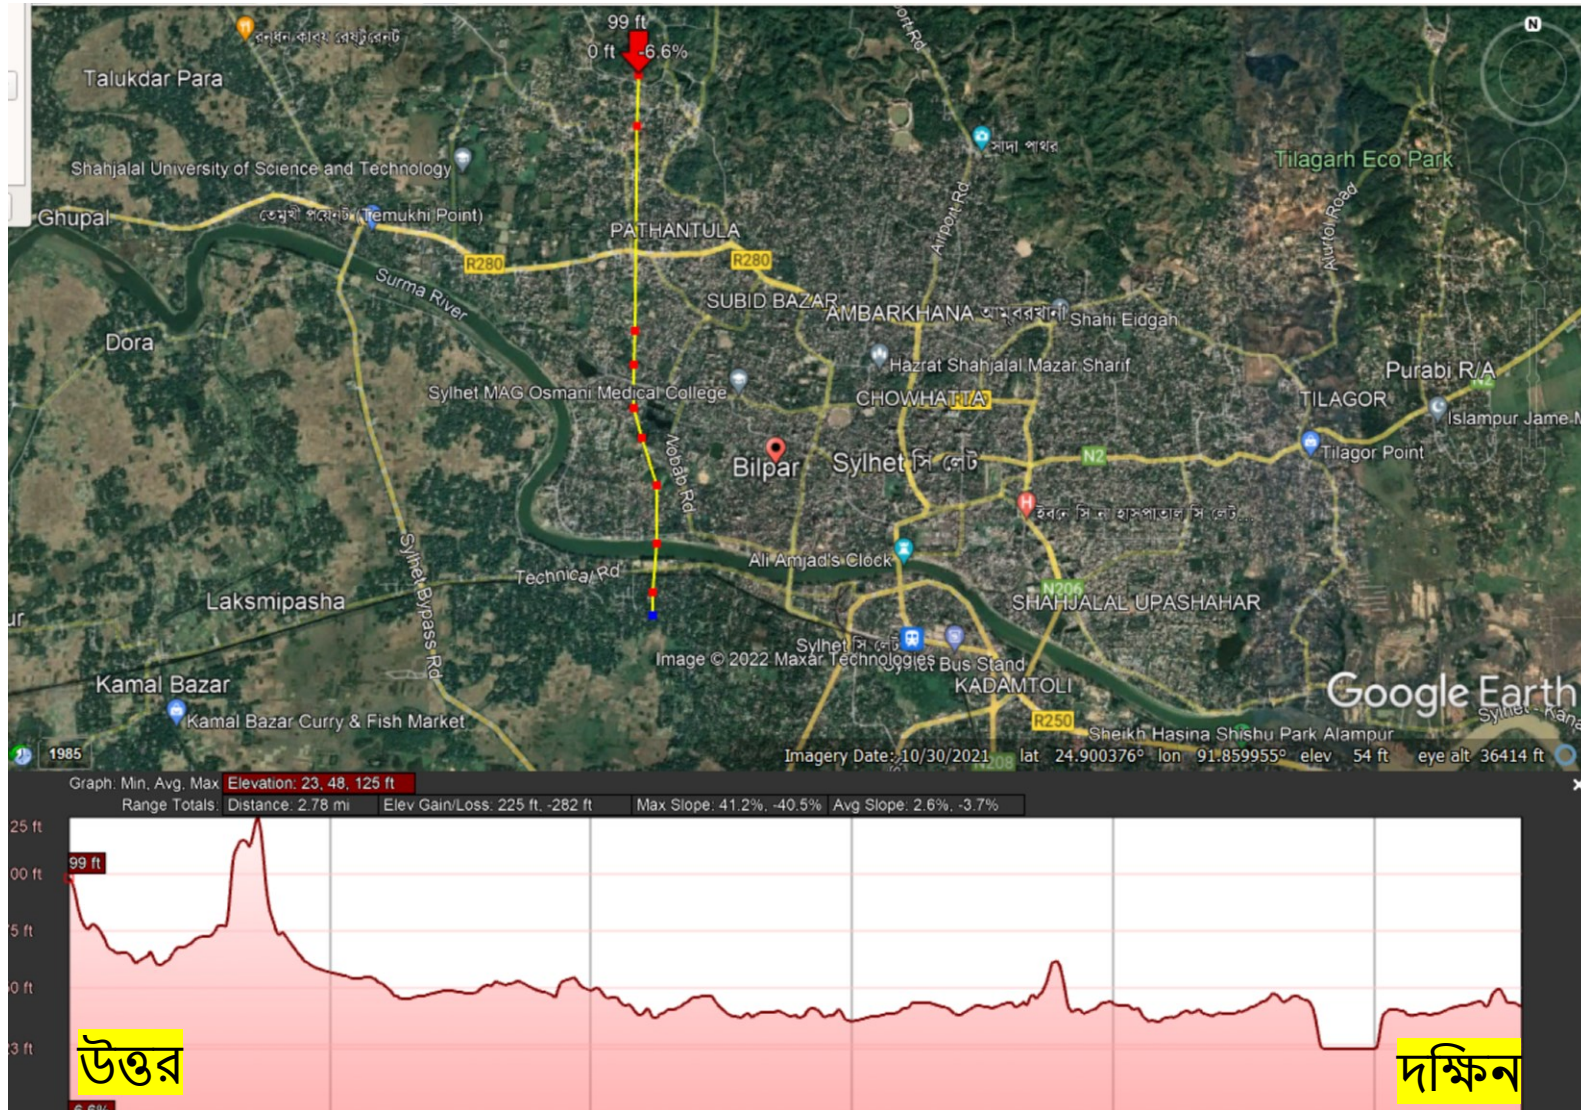
# Topographic profile along a North-South Transect

The city area is titled toward south

East-west bound roads are impediments to surface run-off

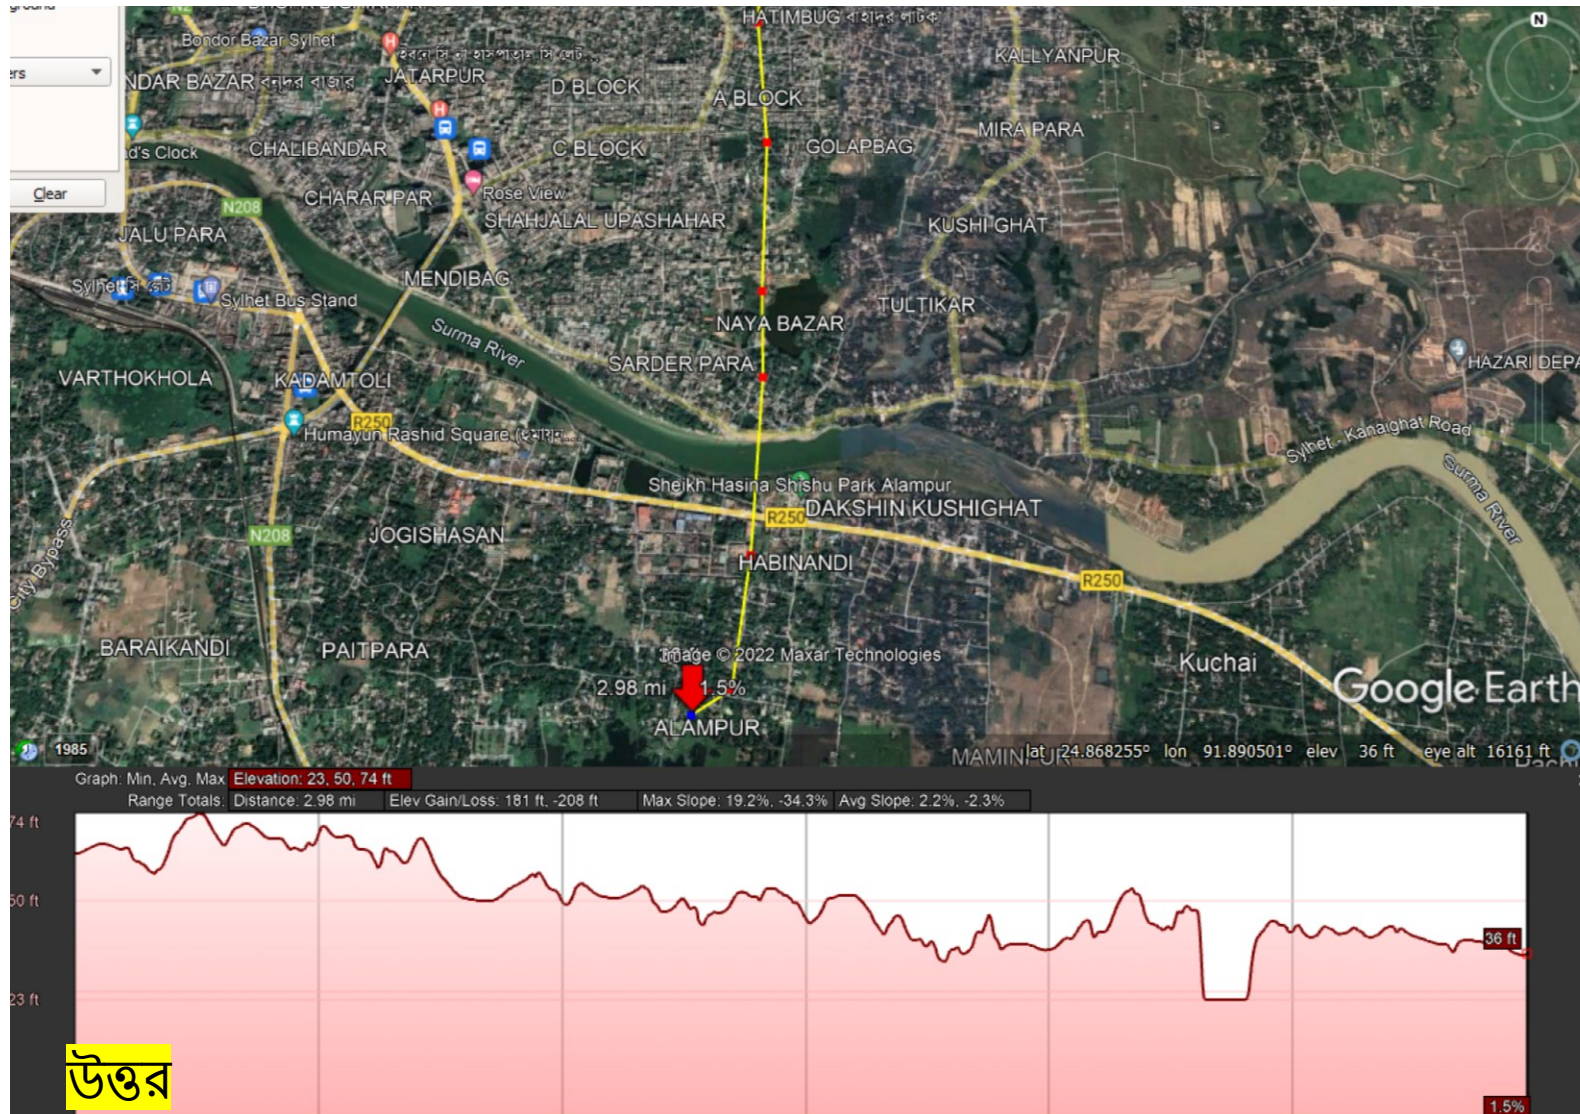
# Topographic profile along a North-South Transect

The city area is titled toward south

East-west bound roads are impediments to surface run-off

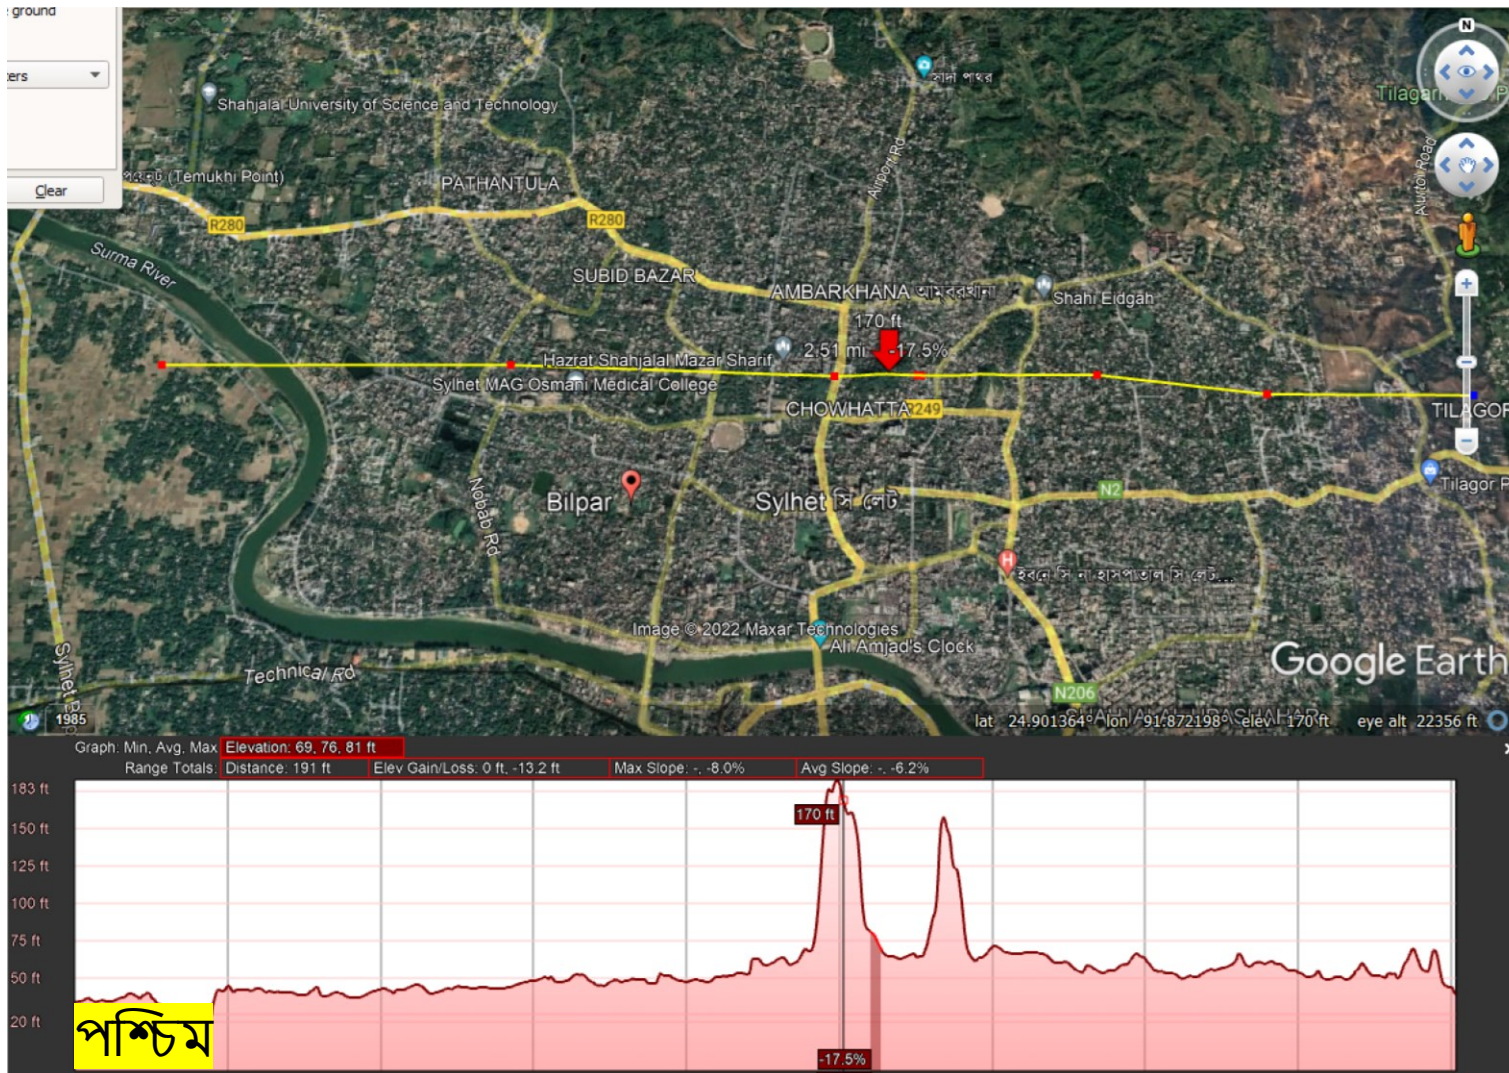
# West-East Topographic Profile along a Transect

The western part of the city slope to west, and the eastern part slopes to east

North-south bound roads are impediments to surface run-off
