# Underlying Causes of Flooding in *Haor* Region and Waterlogging in Sylhet City

**Md. Khalequzzaman, Ph.D.**

Professor of Geology

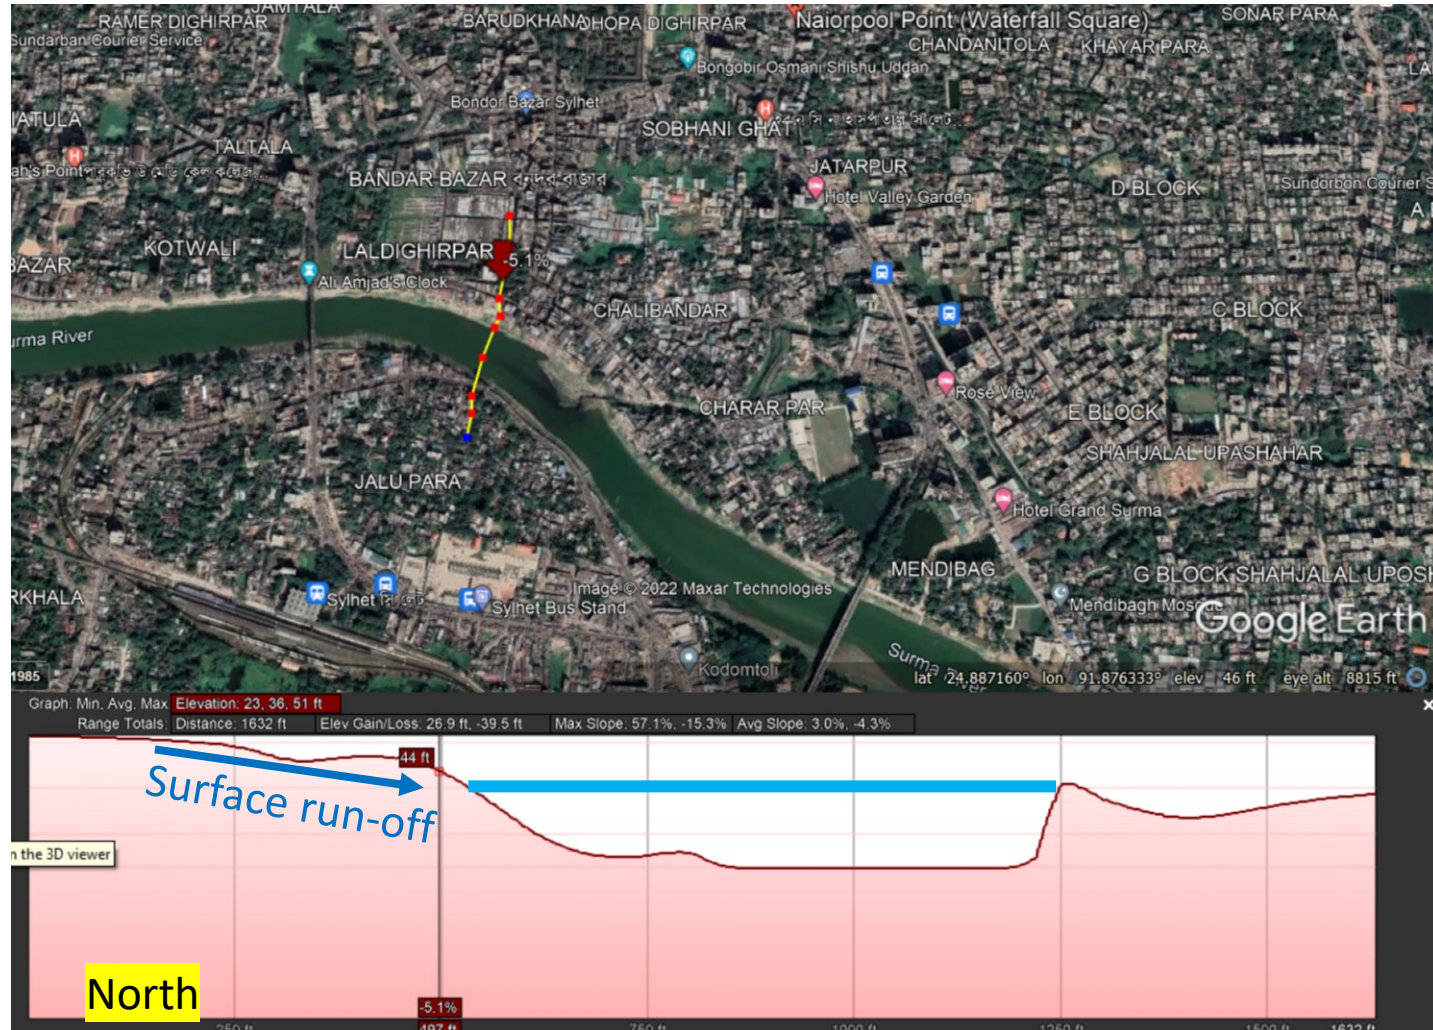
# North-South Topographic Profile across the Surma River

**The northern side of the river is taller than the southern side. The northern side should not flood before the southern side, but normal rainfall causes waterlogging on the northern side. This is a localized problem.**

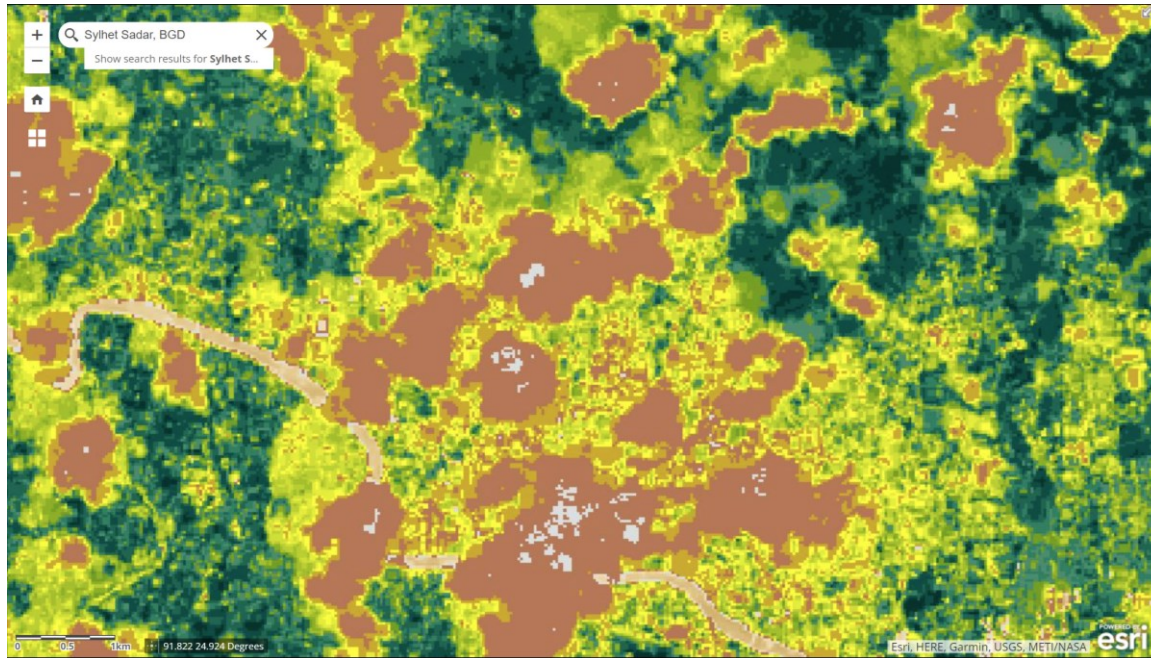
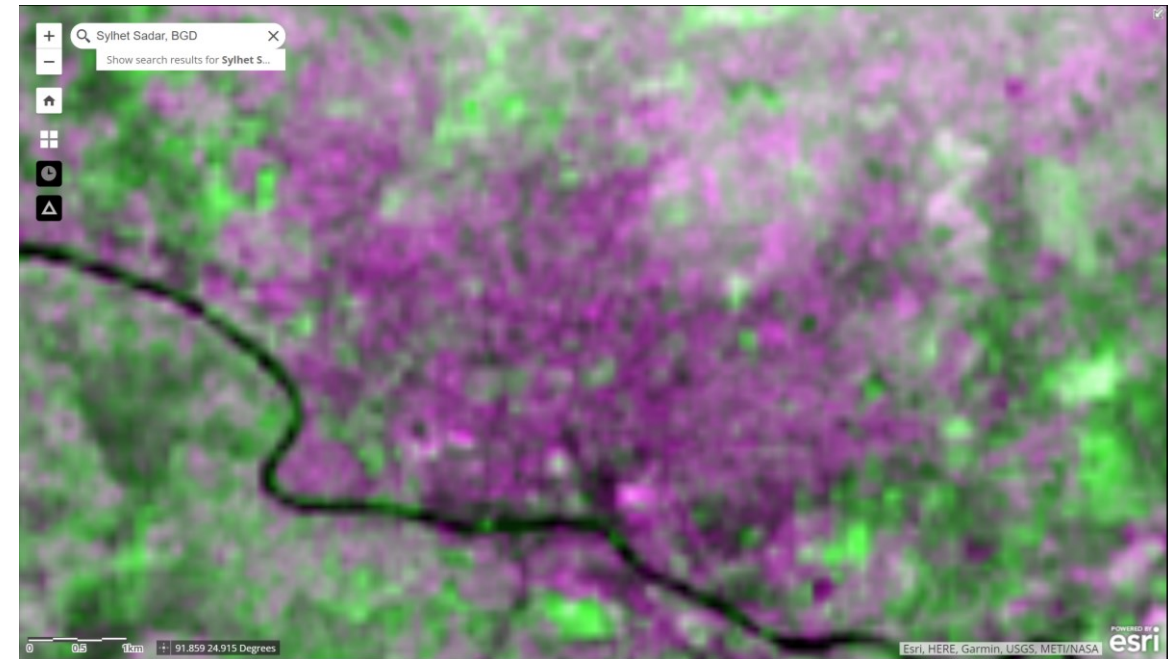
# Change in Vegetative Cover (1975-2021)

**Satellite image: dark green represents vegetation and orange represents built-up area (2021)**

**Analysis of satellite image: Purple represent areas that are converted to built-up from other landuses between 1975 and 2021**

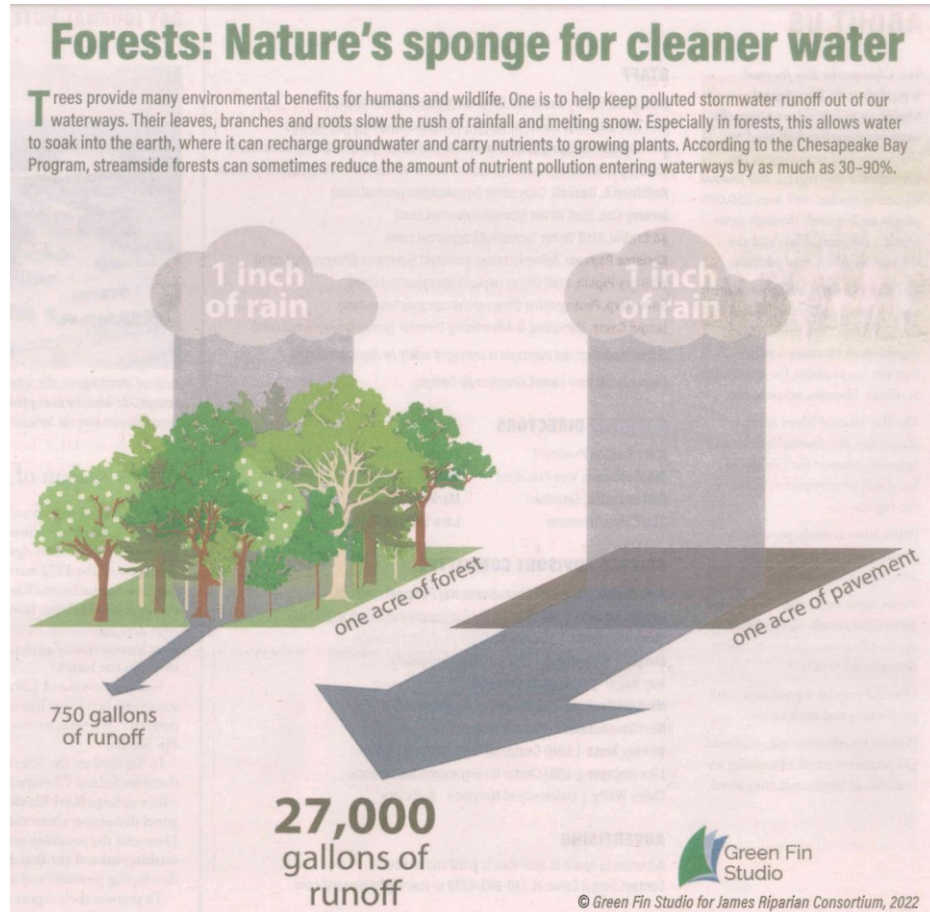
# Impact on surface run-off: Vegetative area vs. impervious area

- One inch of rain over one acre of land generates 27,152 gallons of water
- One acre of vegetated land generates 750 gallons of surface run-off
- Same amount of rain on impervious surfaces generate 27,000 gallons of surface run-off, i.e. 36 times more run-off that need to be accommodated by drainage network

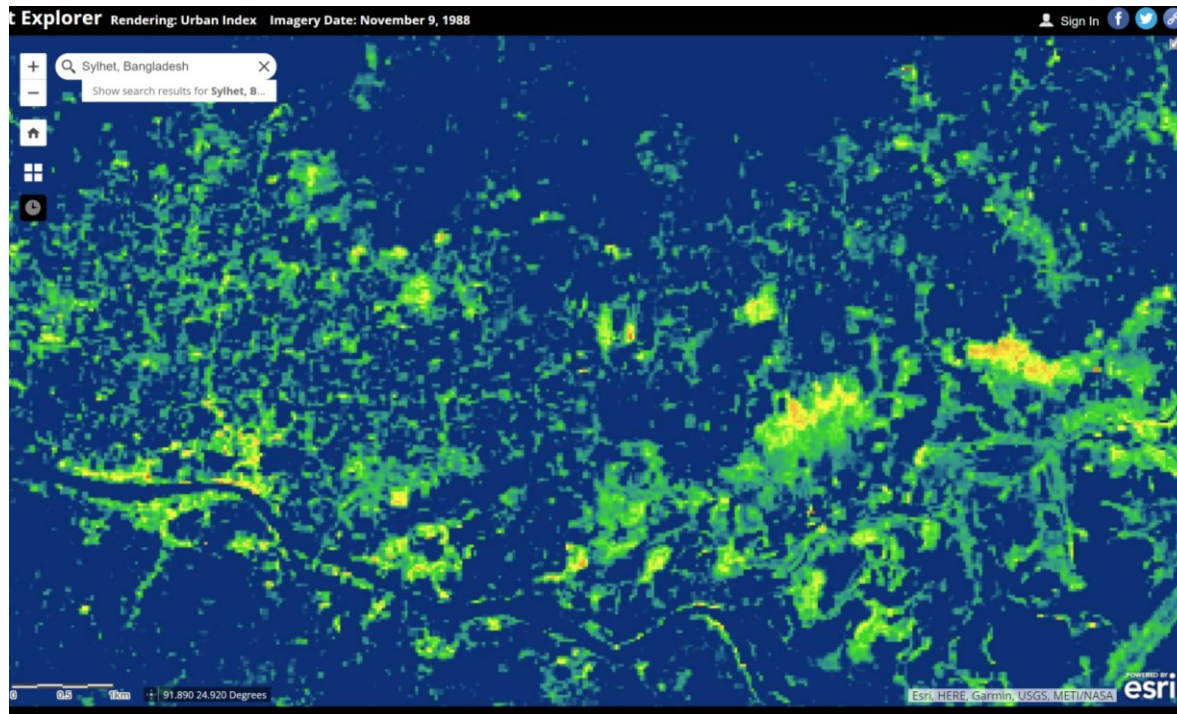
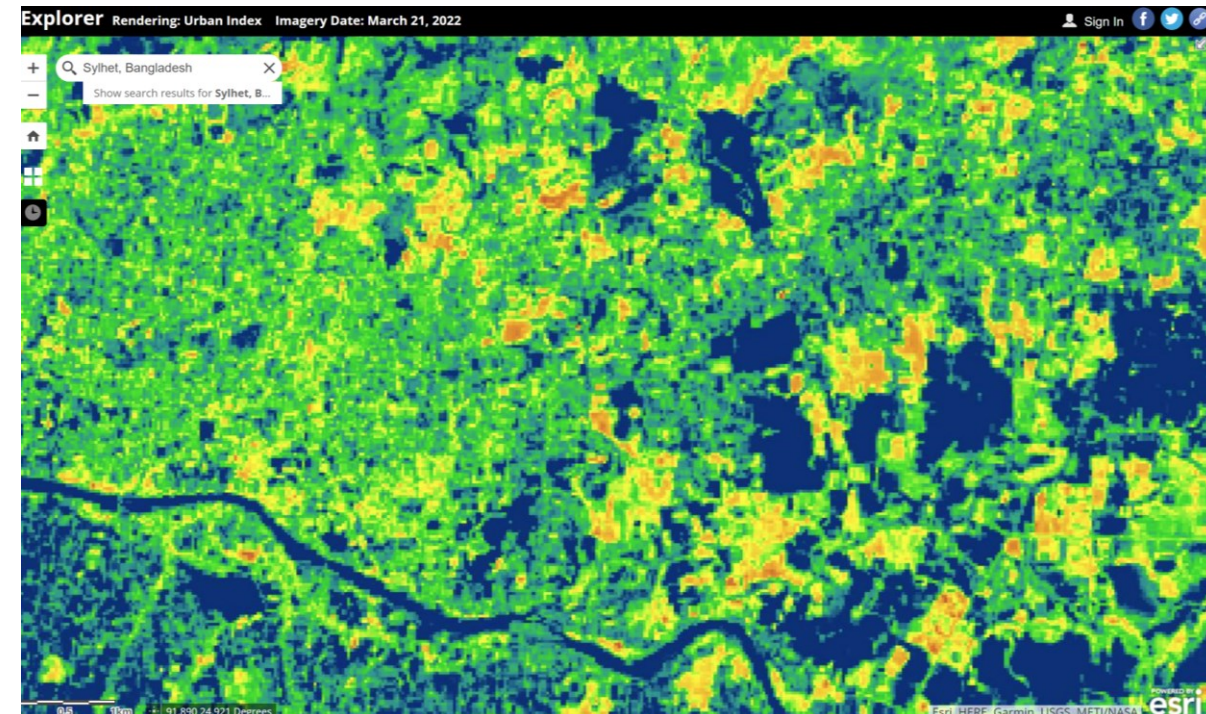
# Change in the extent of urbanization: 1988-2022

Yellow-green represents urban areas in 1988

Extent of urbanization in 2022

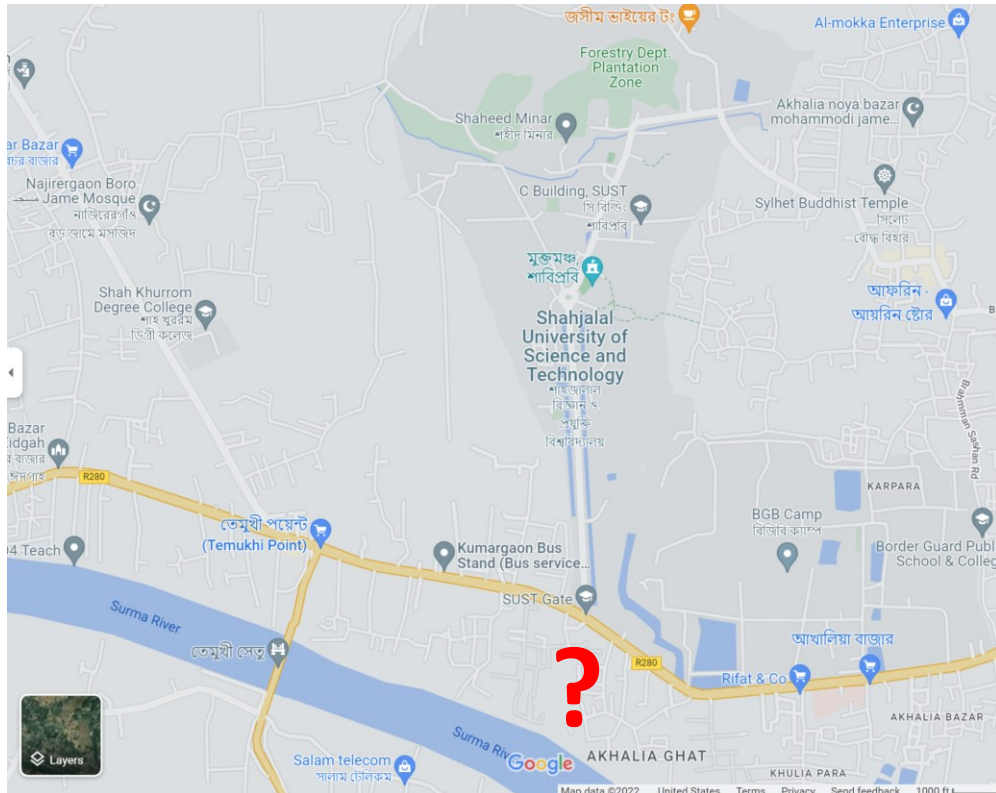
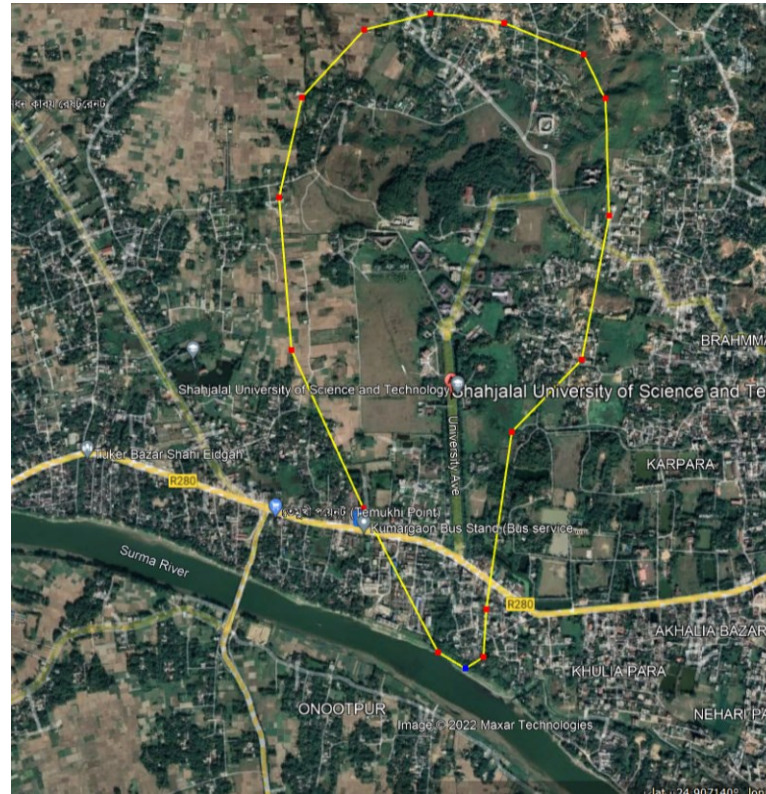
# State of the drainage near SUST

**Watershed area~ 2.6 sq.km= 665 acres~ 1 sq.mi=> Desired cross section of the canal =  $72 \cdot (\text{area in sq.mi})^{0.657} = 73 \text{ sq.ft} = 10 \text{ ft} \cdot 7.3 \text{ ft}$  for natural landuse and land cover**

Name of Creek	Watershed Area (mi) <sup>2</sup>	Watershed Area (acres)	Expected minimum cross-sectional area of natural creek (ft <sup>2</sup> )	Peak discharge (Q <sub>p</sub> ) in cusec from a 0.4 inch/hour rain
Malni Chhara	3.86	2500	175	700
Murarichand College Creek	2.7	1729	138	484
SUST Canal	1	665	73	186
Sonar Para Canal	0.37	250	38	70

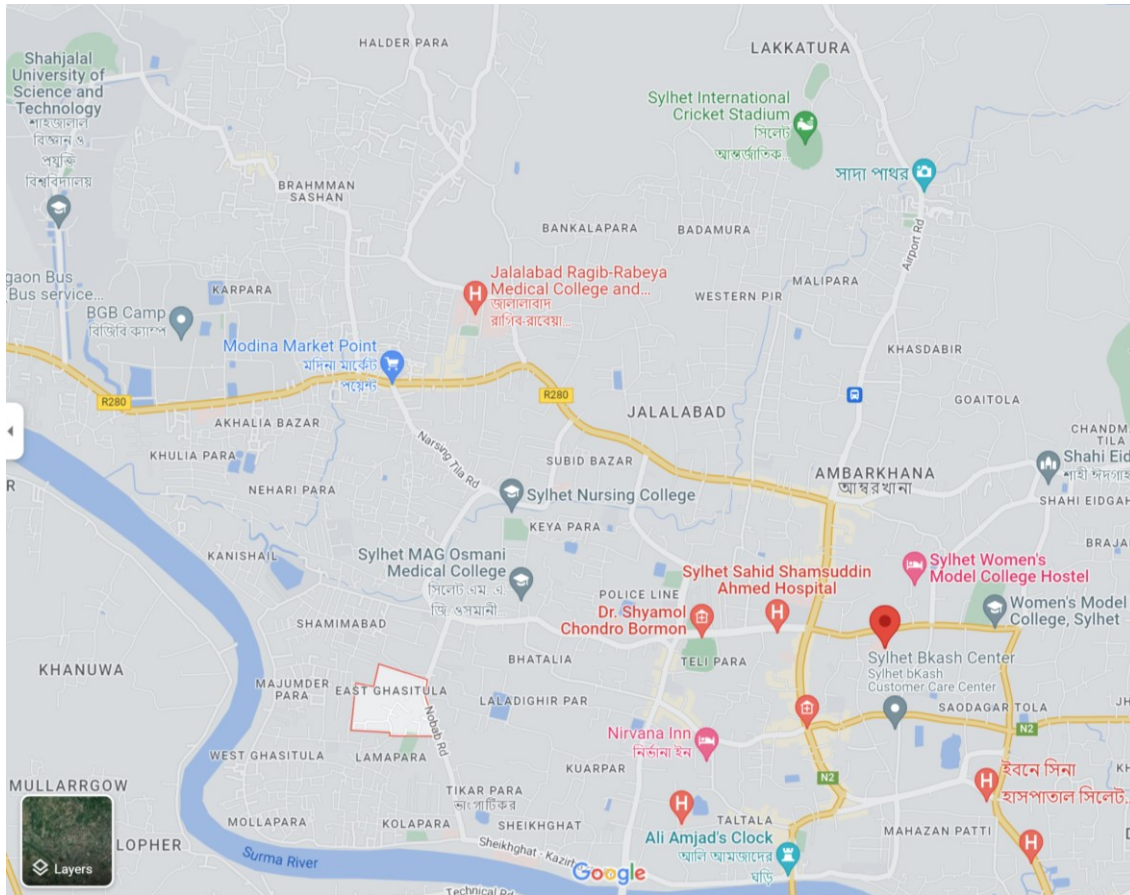
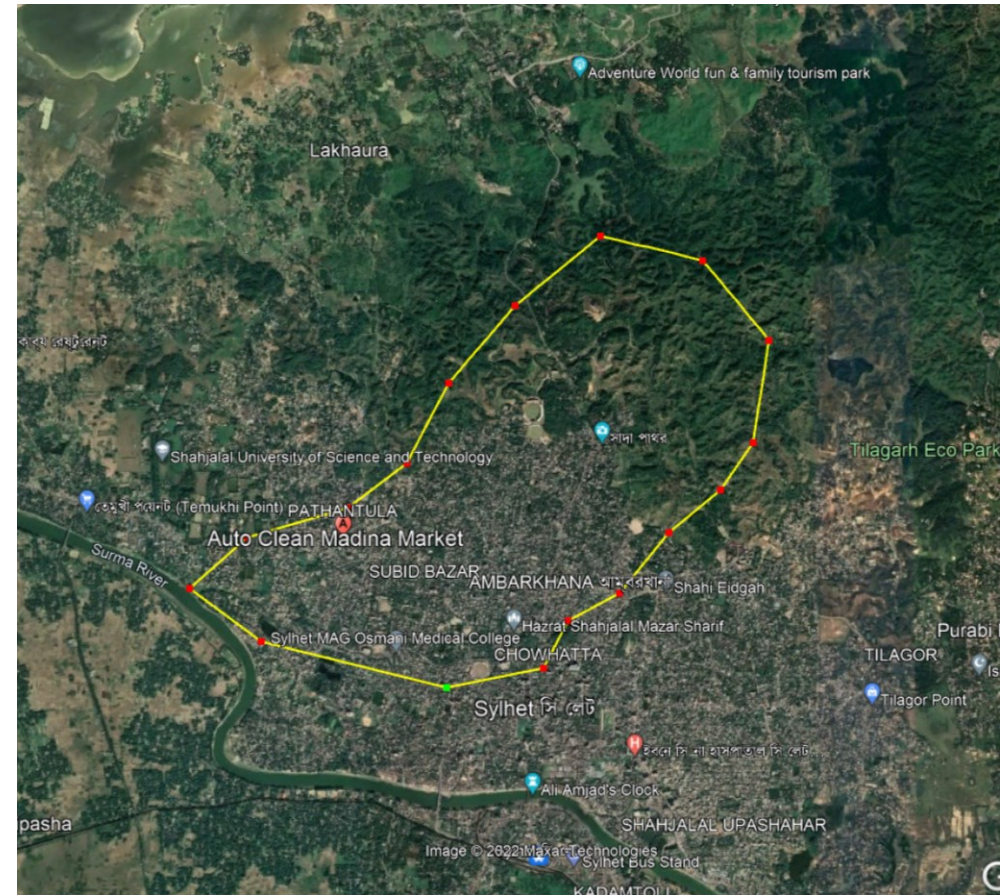
# Sorry state of the Malni Chhara

**Watershed area~ 10 sq. km=2500 acres=3.86 sq. miles**

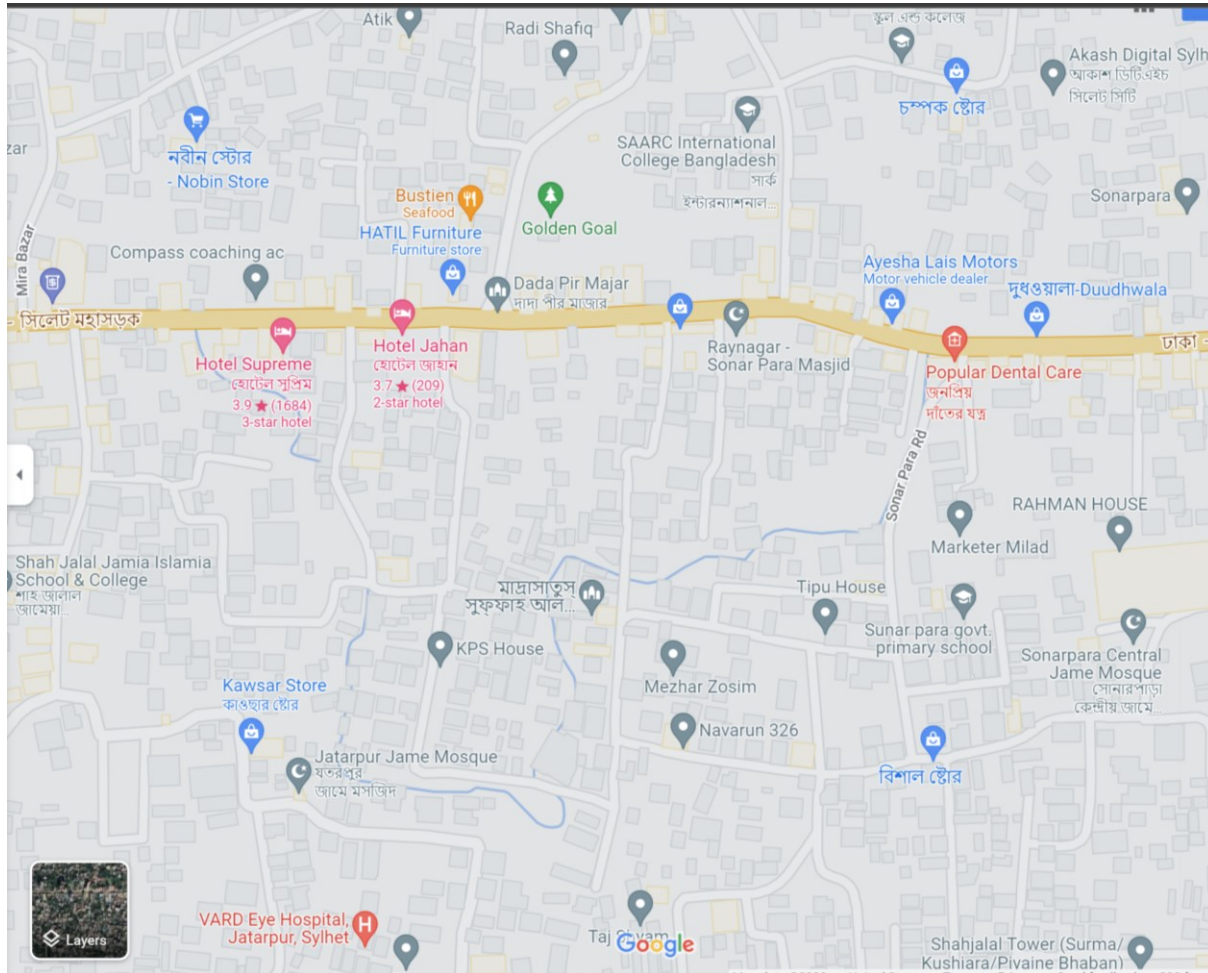
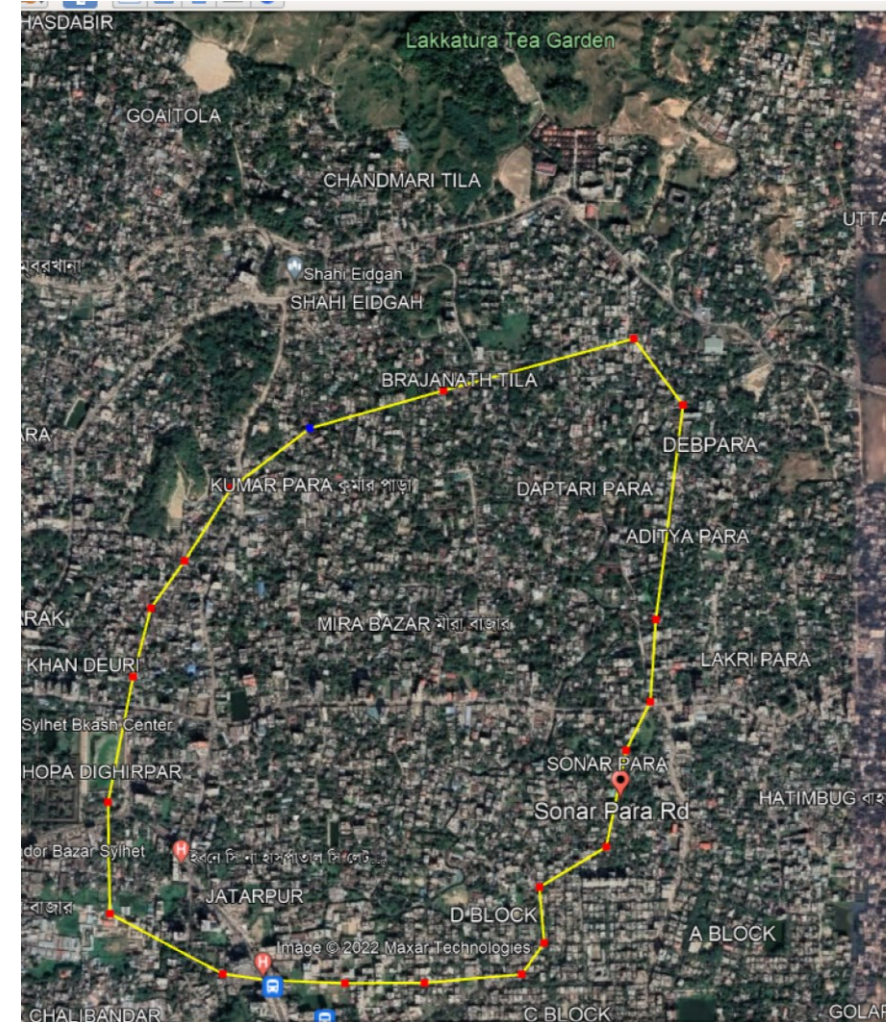
# Sonar Para Road Canal

**Watershed area~ 1 sq.km~ 250 acres=0.387 sq.mi**

- If one sq.km area (such as the Sonar Para Canal) receives 90 mm of rain, then 90,000 m<sup>3</sup> of water will be generated. If these waters cumulates in 10% of the low-lying elevations, then the depth of water will be 0.9 m or 2.9 feet (waist-deep)
- These rain event will generate a maximum flow of 70 to 90 cusec for a few minute, following the Rational Equation below:
  - Rational Equation =  $Q_p = CiA$  (where  $C=0.70-0.95$ ;  $i=0.4$  in/hr;  $A=250$  acres)
- If there is a culvert with a cross sectional area of 25 sq.ft (5 ft \* 5 ft), then water velocity will reach up to 3 to 4 ft/sec (very fast).

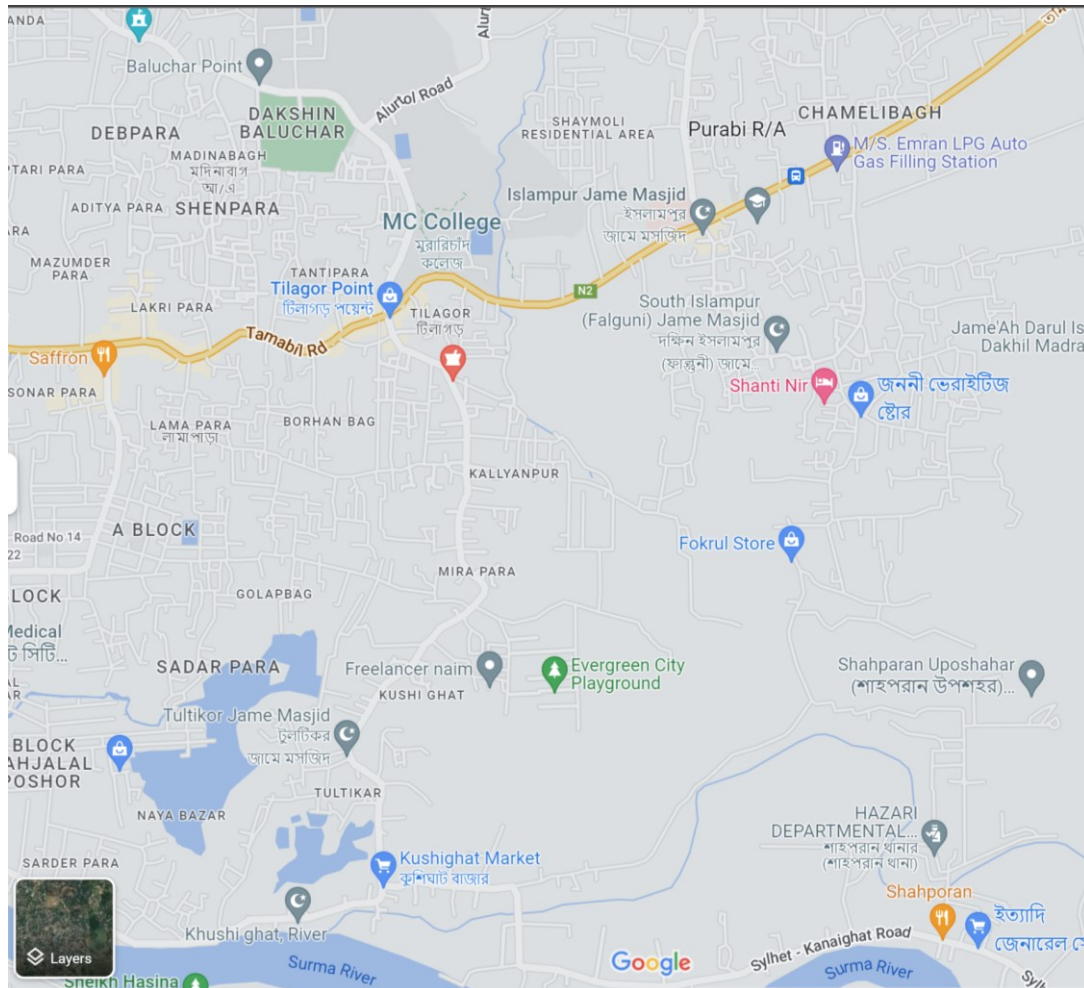
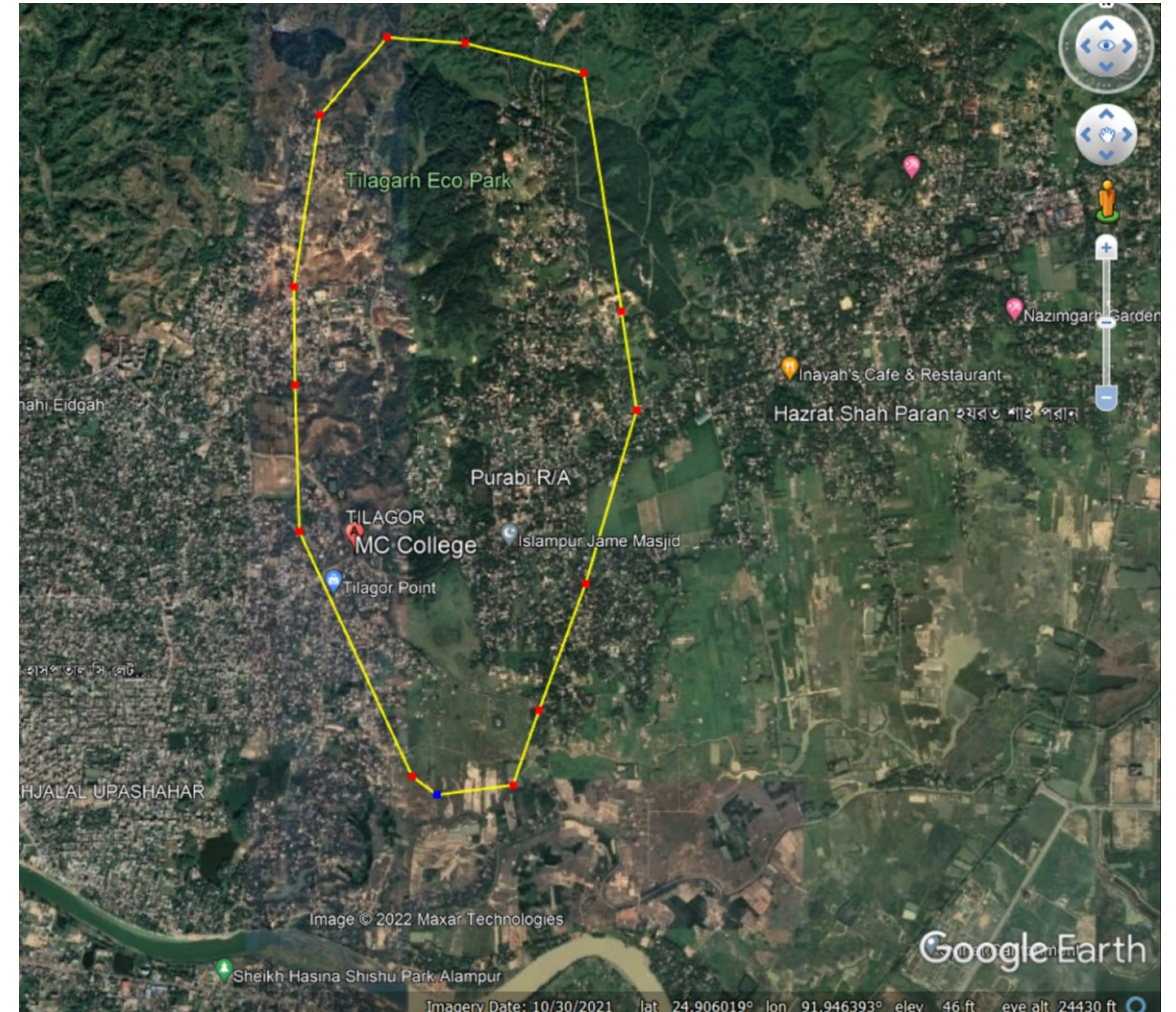
# Murari Chand College Creek

**Watershed area~ 7 sq. km= 1729 acres= 2.7 sq. mi**

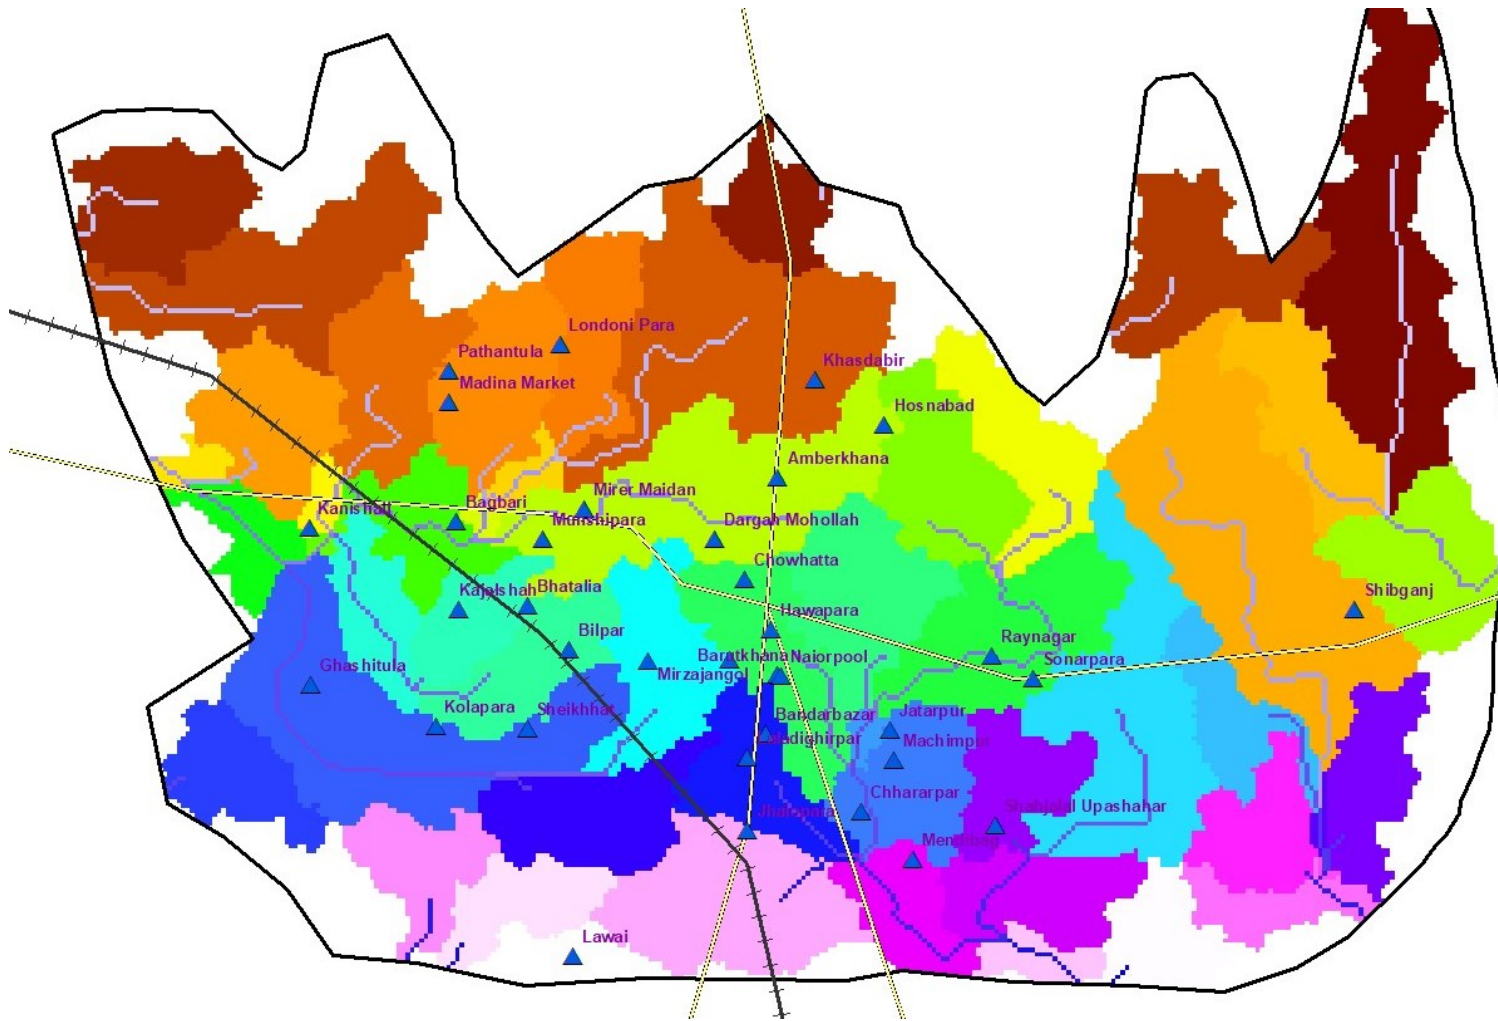
# Area-based sub-watersheds for natural drainage network

Similar hydrologic analysis has to be the cornerstone of all future plans for management of surface run-off and waterlogging issues. This type of watershed and natural drainage delineation can serve as guide in identifying and recovering abandoned and encroached channels and creeks. Storm drain also need to follow natural slope of the watershed and sub-watersheds.
